## Remington Arms Co., Inc. Product Service Legal Case #:4222

### Remington/700/CF/BA

> Re: Remington Model 700, 270-Fire Caliber Serial #G6587737

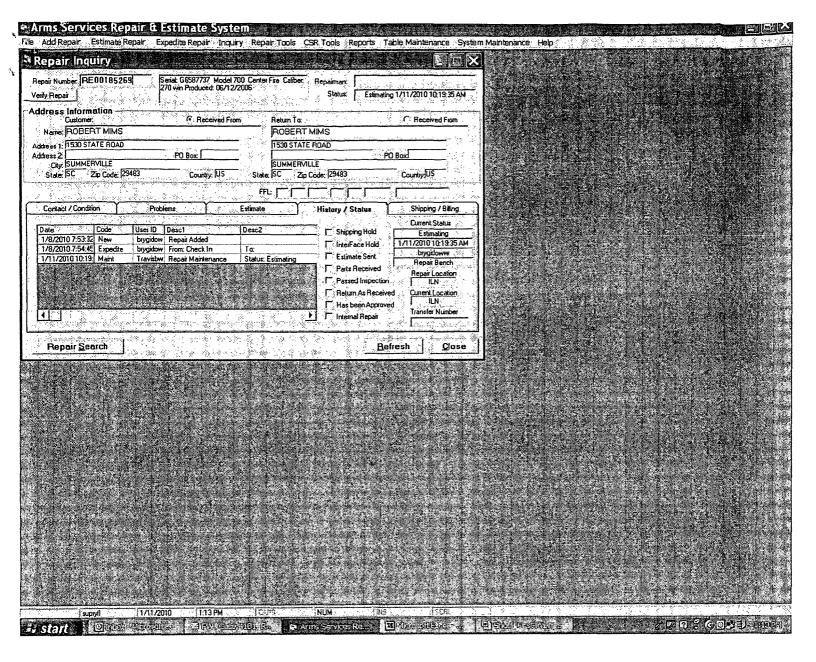
Sub-Assembly	X-Mark Pro

Part	Sub-Part	Code	Comment			
	Examiner	]	B.TRAVIS			
	Exam Date	]	1/11/2010			
Examination	Product Type	]	RF			
	Action Type		A			
	Assigned To		F.SUPRY			
Cause	4038	Could Not Duplicate Concern				
	Description	]	22" 270 WIN			
	Date Code		PA			
Barrel	Bore Plugged	False				
	Bulged	False	]			
			Ĵ

We did replace the TA on this gun previously - and we could not duplicate it again. We will install a new TA and have it tested again. TRED 1/11/10

ll a new 1 rig assm and have it tested again.cm
