# **TLW2170**

## **INTERIM PROGRESS REPORT B**

### **40-X X-MARK PRO TRIGGER FAILURE**

#### **40-X XMP DAT (S/N: TA#17)**

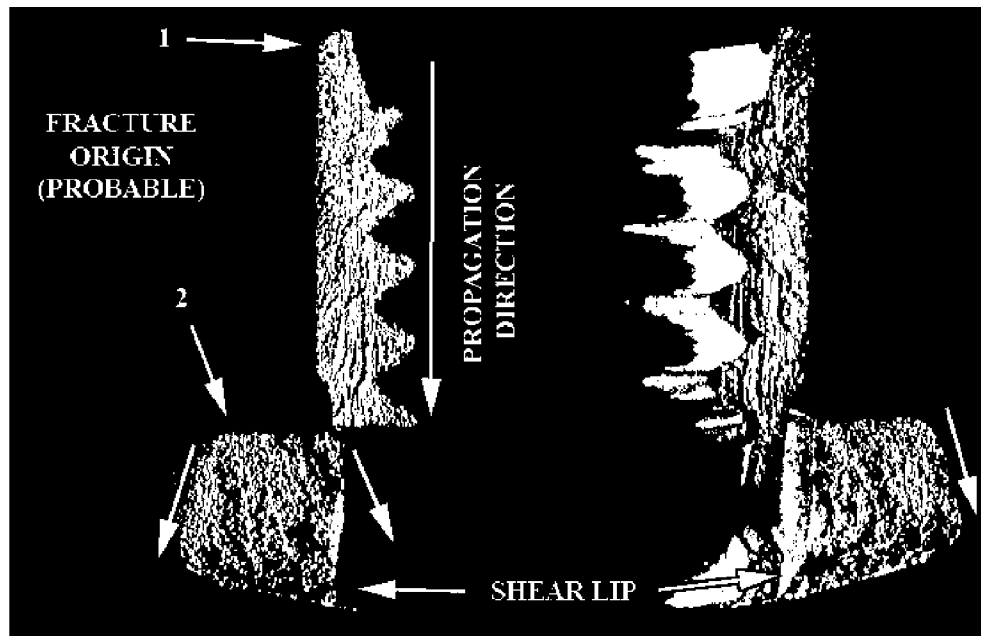
Figure 4 presents an image of the fracture surfaces as viewed with low-angle incident lighting. This image further confirms the evidence presented in Figure 3. The fracture propagated from the top surface of the boss and the top surface of the trigger bow cross section to the bottom of the trigger bow, ending at the shear lip region. The fracture initiation site is most likely one of two locations. The first probable location is the top of the trigger adjustment screw boss on the left side of the image presented as Figure 4. The second probable location is the top outer corner of the trigger bow cross section on the left side of the image presented as Figure 4.

Based on the direction of the fracture propagation, the load had to be applied to the rear of the trigger bow and applied in a forward direction. This orientation directly opposes the intended direction of force application to the trigger bow. Most likely, this failure occurred as a result of handling or abnormal loading the trigger mechanism.

**Figure 4.** The fracture surface of the failed trigger showing the fracture morphology of both the trigger bow region (lower edges with the shear lip) and the boss region (threaded portion).
