**TLW2170**  
**INTERIM PROGRESS REPORT A**  
**40X X-MARK PRO TRIGGER FRACTURE**  
**40X XMP DAT (S/N: TA#12)**  
**Endurance Testing Measurement / Accidental Impact**

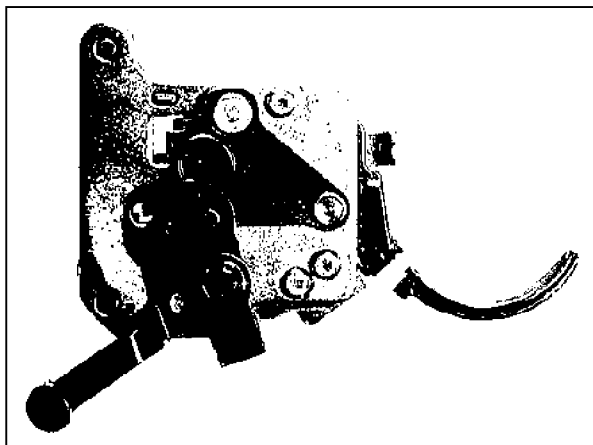
A trigger failure occurred during the measurement routine of the endurance testing portion of the DAT for the 40X X-Mark Pro fire-control conducted on March 28, 2007. Trigger assembly #12 (TA#12) was accidentally impacted against the measurement fixture which precipitated a failure of the trigger by fracture. At the time of failure, TA#12 had 500 rounds fired and was being utilized in test firearm A12. The measurements were being conducted by J. Ronkainen (Staff Engineer) using the optical comparator. When the trigger assembly was removed from the fixture, the trigger impacted the T-slot table fixturing of the optical comparator. This impact resulted in the fracture of the trigger. Figure 1 presents an image of the failed trigger assembly.

Figure 1. The failed TA#12 test sample.

TA#12 was removed from the DAT testing protocol. The DAT test was continued with TA#13 substituted for TA#12 for the remainder of the endurance testing. No other changes are planned for the remainder of the DAT. The failed trigger assembly was returned to J. Ronkainen.

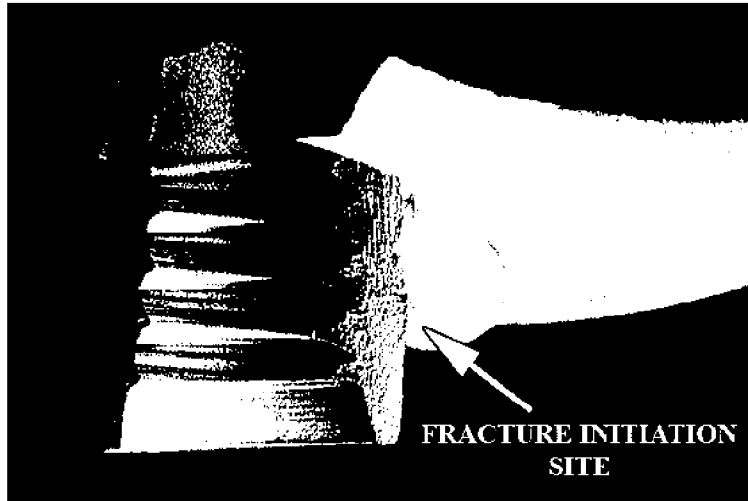
The failure was a result of the impact of the trigger coupled with the geometry of the welded boss on the trigger. The welded boss created a notch that acted as a stress riser, at which the fracture initiated. In the production version, this weld will not be present; instead, the boss will be molded into the MIM trigger geometry without the presence of a notch. It should be noted also that the loading conditions which resulted in the failure are **NOT** typical of normal usage conditions for the trigger assembly. Most likely, this type of impact would not happen in the field due to the presence of the trigger guard on the assembled rifle.

Figure 2 presents an image of the fracture surface of the trigger bow with the fracture initiation site identified. The fracture initiated at the outside surface of the screw boss at a notch created by the intersection of the weld bead and the trigger adjustment screw boss. Figure 3 presents a side-view image of the failed trigger at the fracture initiation site location. This image provides an illustration of the notch created between the weld bead and the trigger adjustment screw boss. In the production design, the trigger adjustment screw boss will be molded into the trigger geometry and the weld bead will not be required. This will eliminate the potential of a notch existing and minimize any stress risers at this location on the trigger.

**Figure 2. The fracture surface of the failed trigger showing the location of the fracture initiation.**

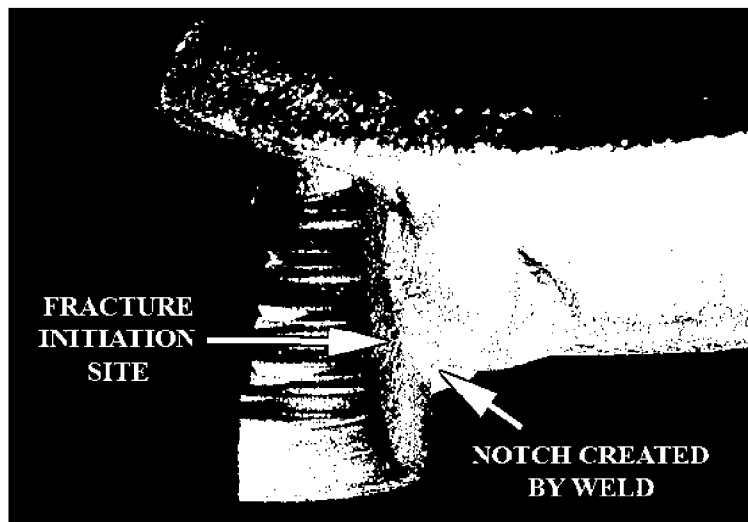
**Figure 3. A side-view of the fractured trigger showing the location of the fracture initiation site relative to the notch created between the weld bead and the trigger adjustment screw boss.**
