# REMINGTON ARMS COMPANY, INC.

MODEL 700/COMPLAINTS - BROKEN TRIGGER CONNECTORS

MODEL 700, 600, 660 - CONNECTOR REPLACEMENT

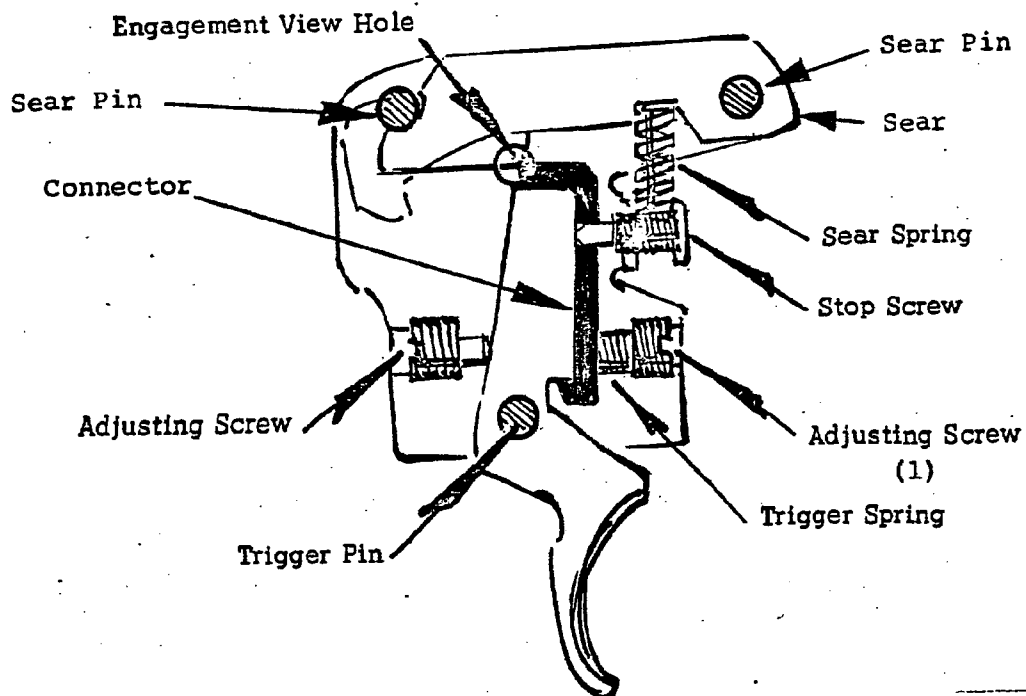
A word of caution should be passed on to gunsmiths who replace connectors in either Model 700 or Model 600 - 660 trigger assemblies. After the Connector has been placed in the trigger housing and the trigger stop screw is re-installed, the gunsmith must take extreme care that the end of the screw actually passes through the connector hole and contacts the trigger.

The trigger travel can be adjusted by turning the trigger stop screw. However, if the trigger stop screw is not inserted in the connector hole but bears on the side of the connector, attempts to adjust trigger travel by tightening the trigger stop screw will break the connector.

1. Remove 2 sear pins.
2. Remove sear and sear spring.
3. Remove trigger adjusting screw (1) and trigger spring.
4. Remove stop screw.
5. Remove broken connector.
6. Insert new connector from top of assembly.
7. Install stop screw (Special precaution required to be certain that screw passes through hole in connector. If screw is not through hole, attempts to adjust will break connector.)
8. Install trigger spring and adjusting screw.
9. Install sear, sear spring and pins.
10. Reassemble to rifle.
11. Adjust sear engagement, trigger travel and pull.
12. Stake screws.
