REMINGTON ARMS COMPANY, INC.

TITLE OF PROJ. 700 F/E TIPS

SUBJECT ADHESIVE STUDY -

TIPS SHOOTING OFF IN GILBERT COMPUTER

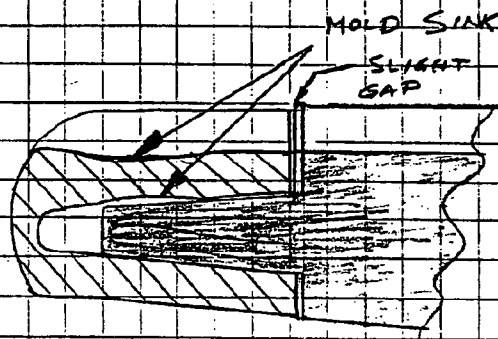
PHYSICAL MATCH OF PARTS

GAPS ARE .005" TO .010"

1. OPERATORS COMPLAIN OF SLIGHT GAP AT BOL GROOVE
2. PRESSURE POINTS SHOWN LEAVE GAP OF NO PRESSURE BUT GOOD ADHESION IS NOT NECESSARILY AT PRESSURE POINTS AS WOULD BE SUPPOSED.
3. DESIGN MIGHT BE CHANGED TO IMPROVE UNIFORMITY OF PRESSURE POINTS BUT EXTENT OF PROBLEM DOESN'T SEEM TO JUSTIFY COST.
