August 29, 1983

TO: C. E. RITCHIE

FROM: S. R. FRANZ

REPORT TITLE: M/700 BDL LEFT HAND - EXTRA GAS RELIEF HOLE IN RECEIVER

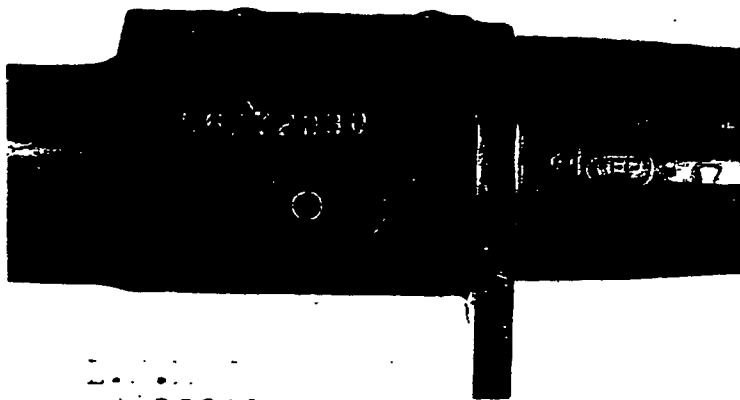
Picture 1

A small quantity of L. H. M/700 receivers were run in production with two gas relief holes in the front receiver ring, (See Appendix for pictures). The extra hole is hidden by the stock on the right side of the receiver. W. A. Warren, Quality Control Foreman, sent one L. H. M/700 BDL rifle in .270 caliber to the Lab to determine what effect the extra relief hole has on stock damage or shooter safety when a primer is pierced.
