Ilion, NY  
January 6, 1988

Firearms Business Team  
R.B. Sperling  
R.K. Straitman  
A.B. Dana  
R.A. Blackhall  
D.M. Condon

MODEL 700 TRIGGER ASSEMBLY REPLACEMENT PROGRAM

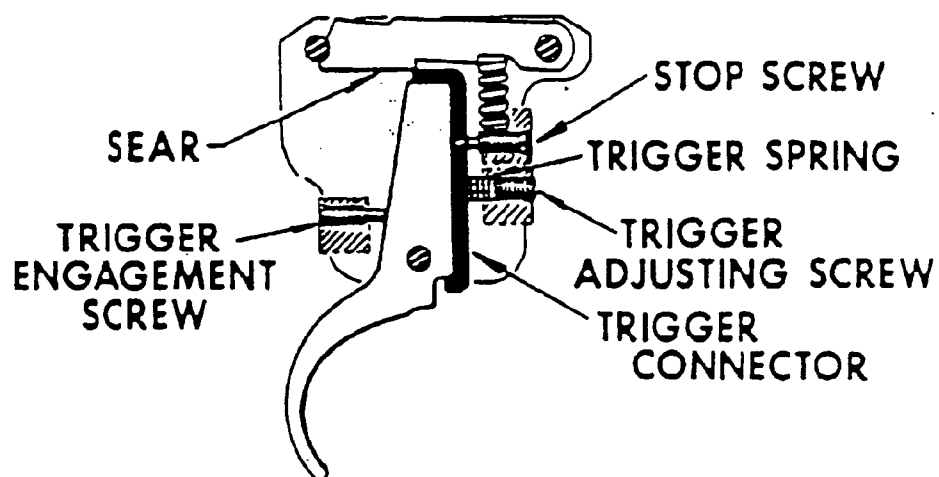
EXHIBIT A

Centerfire rifle trigger assemblies contain a part referred to as a connector that releases the sear safety cam to fire the rifle when the trigger is pulled. This part fits on the forward edge of the upper portion of the trigger assembly. (See Exhibit A)

SECTION VIEW, MODEL 700 SERIES TRIGGER ASSEMBLY
