**REMINGTON ARMS COMPANY INC.
ILION, NY PLANT SITE**

TEST REPORT

**M/700 XMP Trigger Assembly
Updated MIM Sear Verification**

Request # 20080006

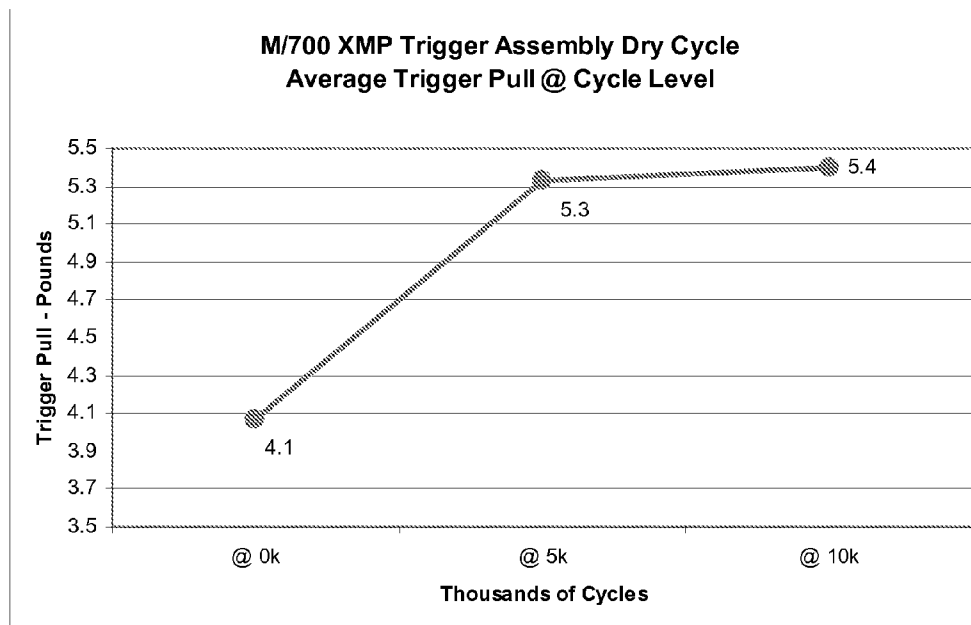
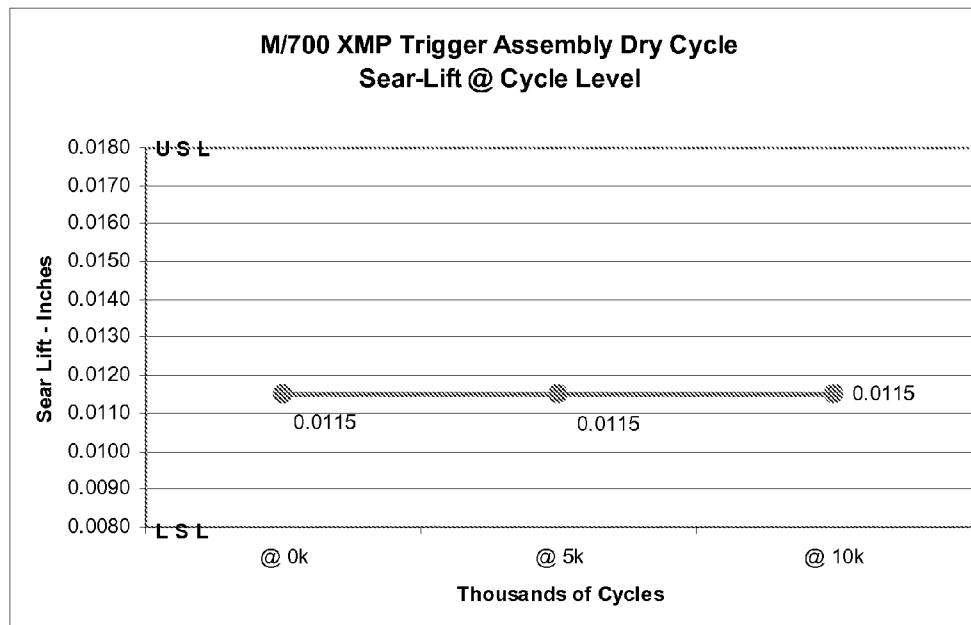
Dry Cycle - The dry cycle phase was completed without any problems - no breakages or abnormal wear was evident. The measurements were consistent with previous testing done on the trigger assemblies.
