Remington Arms Company, Inc.

TLW2170
INTERIM PROGRESS REPORT A
40X X-MARK PRO TRIGGER FRACTURE
40X XMP DAT (S/N: TA#12)
Endurance Testing Measurement / Accidental Impact

March 29, 2007
TLW2170 Project 241460

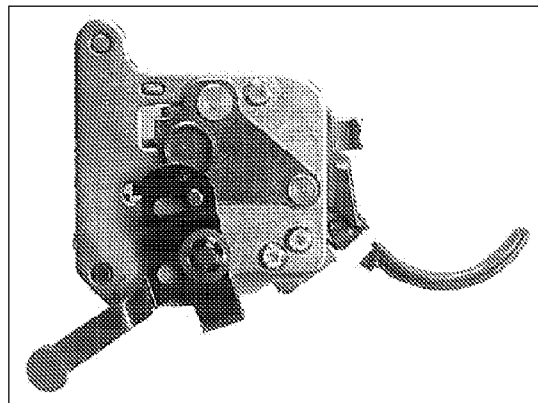
A trigger failure occurred during the measurement routine of the endurance testing portion of the DAT for the 40X X-Mark Pro fire-control conducted on March 28, 2007. Trigger assembly #12 (TA#12) was accidentally impacted against the measurement fixture which precipitated a failure of the trigger by fracture. At the time of failure, TA#12 had 500 rounds fired and was being utilized in test firearm A12. The measurements were being conducted by J. Ronkainen (Staff Engineer) using the optical comparator. When the trigger assembly was removed from the fixture, the trigger impacted the T-slot table fixturing of the optical comparator. This impact resulted in the fracture of the trigger. Figure 1 presents an image of the failed trigger assembly.

Figure 1. The failed TA#12 test sample.

TA#12 was removed from the DAT testing protocol. The DAT test was continued with TA#13 substituted for TA#12 for the remainder of the endurance testing. No other changes are planned for the remainder of the DAT. The failed trigger assembly was returned to J. Ronkainen.

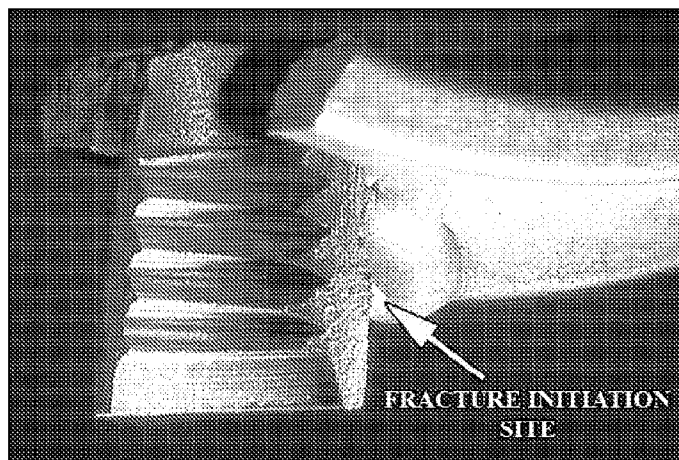
The failure was a result of the impact of the trigger coupled with the geometry of the welded boss on the trigger. The welded boss created a notch that acted as a stress riser, at which the fracture initiated. In the production version, this weld will not be present; instead, the boss will be molded into the MIM trigger geometry without the presence of a notch. It should be noted also that the loading conditions which resulted in the failure are NOT typical of normal usage conditions for the trigger assembly. Most likely, this type of impact would not happen in the field due to the presence of the trigger guard on the assembled rifle.

Figure 2 presents an image of the fracture surface of the trigger bow with the fracture initiation site identified. The fracture initiated at the outside surface of the screw boss at a notch created by the intersection of the weld bead and the trigger adjustment screw boss. Figure 3 presents a side-view image of the failed trigger at the fracture initiation site location. This image provides an illustration of the notch created between the weld bead and the trigger adjustment screw boss. In the production design, the trigger adjustment screw boss will be molded into the trigger geometry and the weld bead will not be required. This will eliminate the potential of a notch existing and minimize any stress risers at this location on the trigger.

Figure 2. The fracture surface of the failed trigger showing the location of the fracture initiation.

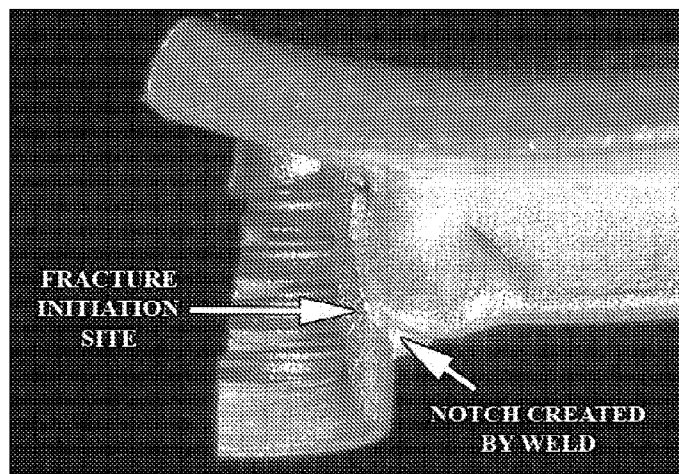
Figure 3. A side-view of the fractured trigger showing the location of the fracture initiation site relative to the notch created between the weld bead and the trigger adjustment screw boss.
