**710 Dry Cycle**  
**6/16/00**  
**Brian Rages**

This report covers a dry cycle test of the 710 bolt / firing pin / fire control to 5000 cycles as requested by Test Lab Work Request # TLW 0010AE.

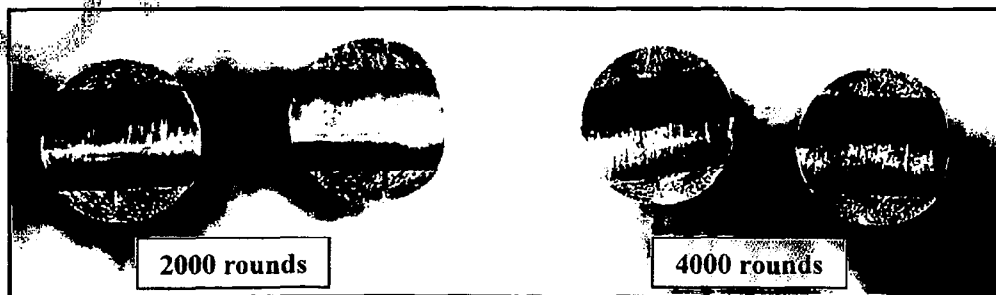
One part failure occurred on the Model 710. When the gun was disassembled after 2000 rounds, the bolt assembly pin was found broken in half. The pin was replaced, and the replaced pin was found broken when the gun was disassembled at 4000 rounds. The pin was again replaced. When the gun was disassembled after 5000 rounds, cracks were developing on the bolt assembly pin. The cracks developed on the top and bottom of the edge of the firing pin clearance hole through the pin. Four cracks could be seen: short, wide cracks on one side of the pin and longer hairline cracks on the other.

Figure 1. Fracture surfaces of bolt assembly pins.

Bolt assembly pins from three long-term Model 710 rifles were examined. One rifle had been fired 10,000 rounds. Its pin had a single crack that was much smaller than the cracks in the 1000-cycle pin from the dry cycle test. The cracks in the 1000-cycle pin could be seen without magnification, but the crack in the pin from the 10,000-round gun could not. Pins from two 5000-round guns were examined and no cracks were found.

The cracking of the bolt assembly pin seems to be caused by a situation that occurs only when the gun is dry-fired. When the gun is dry-fired, the firing pin strikes the back of the bolt head with all of its energy. Without a cartridge in the chamber, the bolt head is free to bound forwards until the tolerance in the bolt assembly pin fit is taken up. The bolt head is then stopped by an impact between the bolt assembly pin and bolt and between the bolt assembly pin and bolt body. These events do not occur when a live round is discharged. When a live round is fired, the firing pin never reaches its full-forward position. Firing a round also places a high pressure on the bolt face, further preventing it from bounding forwards.

Breakage of the pin does not seem to render the gun inoperable or unsafe. The broken pins in the dry-cycle gun were not found until the end of the cycle level being tested.

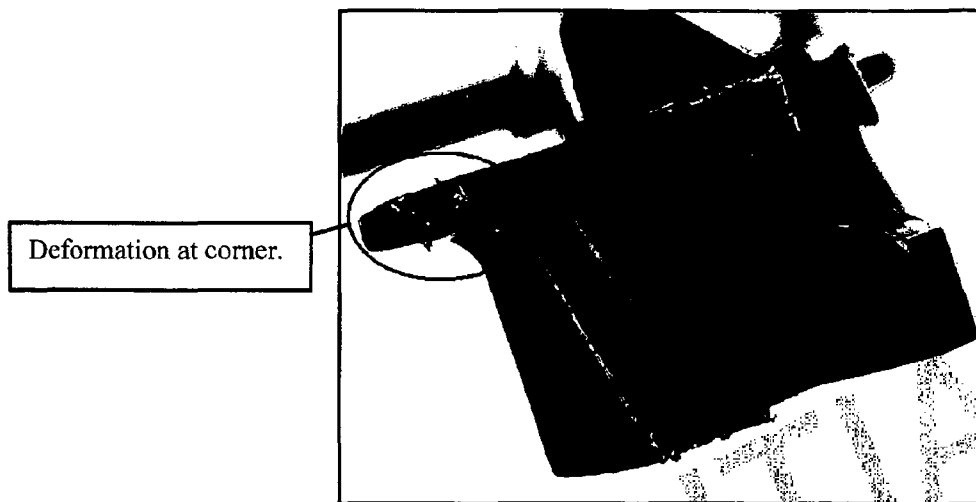
Deformation of the plastic bolt plug also occurred at the bolt-side front corner. This area of deformation may be seen in Figure 3.

**Figure 3. Deformation at corner of 710 bolt plug.**

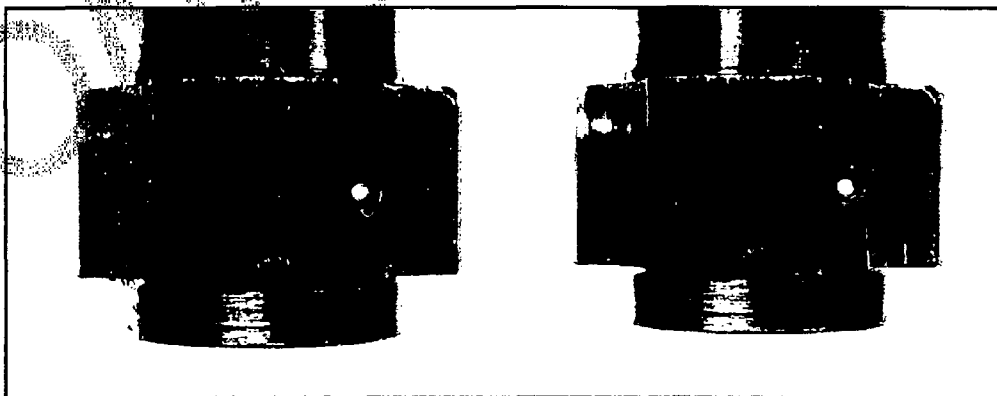
Very little wear was seen to occur on the bolt heads of either gun. Figure 4 contains pictures of the Model 700 bolt lugs before and after the test. The amount of wear shown in the before and after pictures is almost identical.

**Figure 4. 700 bolt lugs, before test (left) and after 5000 rounds (right).**
