G. M. CALHOUN
BRIDGEPORT

MODEL 40X - SERIAL NO. 706
Complaint from Ziniuk & Co.

Re: Capt. Benjamin Naiman, Petch-Tiqva, Israel

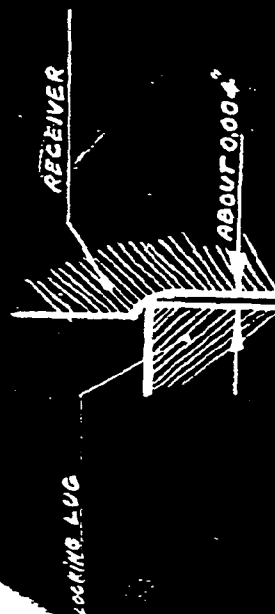
FIG 1

3. Interference Between Receiver & Locking Lug (Fig. 1)

We became aware of this situation incidental to production of first run of rifles and upon investigation it was found that apparently this cut in the receiver was being run with a tool having a radius which was too great and resulted in an interference with the lugs at assembly. In order to compensate for this condition a change was made to open up the diameter of the cut and the radius, which eliminated the interference at assembly.
