M/710 MAGNUM D.A.T.

BORE OBSTRUCTION TEST ORIGIN OF FAILURE REPORT

Prepared by:
Marlin R. Jiranek
Senior Research Engineer
September 29, 2003

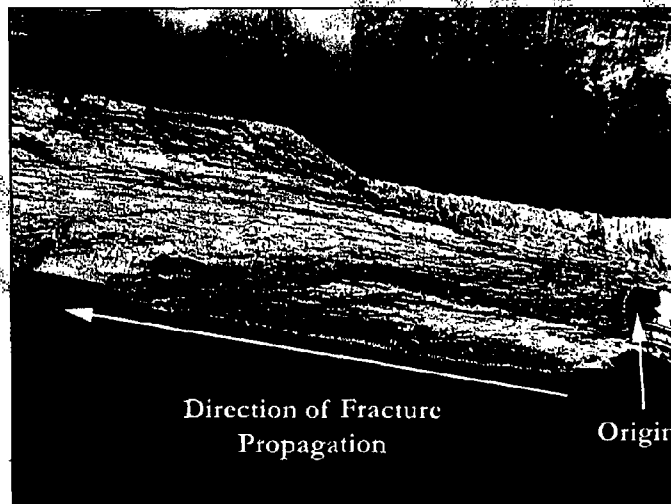
The chevrons are angled orientations on the fracture surface, which visibly appear to be "flow lines". These lines point to the fracture origin and are caused by the propagation of the fracture from its origin.

Figure 2. An image of the left side of the fracture initiation site.

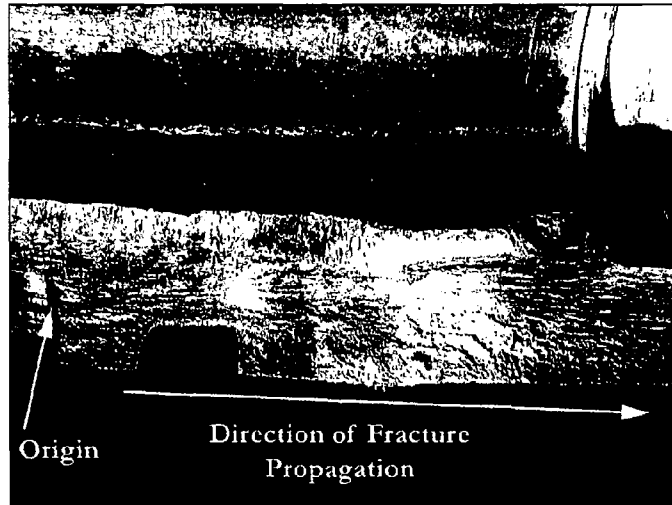
Figure 3. An image of the right side of the fracture initiation site.

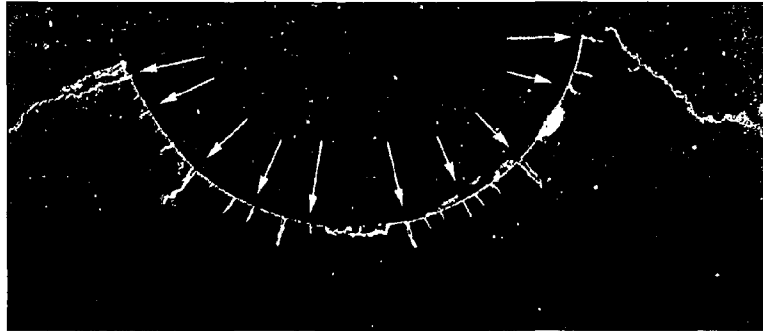
A sample cross section was taken from this region to determine the extent (depth) of the heat-check cracks. Figure 5 presents an image of the cross section of this heat-checked region and clearly depicts the crack depth. The deepest crack measured is

approximately 0.027". The effect on these cracks on the safety of the barrel is a function of crack propagation. This issue is addressed in the endurance portion of the D.A.T. testing and not of issue in this report because it did not have a role in the failure of this barrel.

Figure 5. An image of the cross section of the heat-checked region of the failed M/710 Magnum barrel.

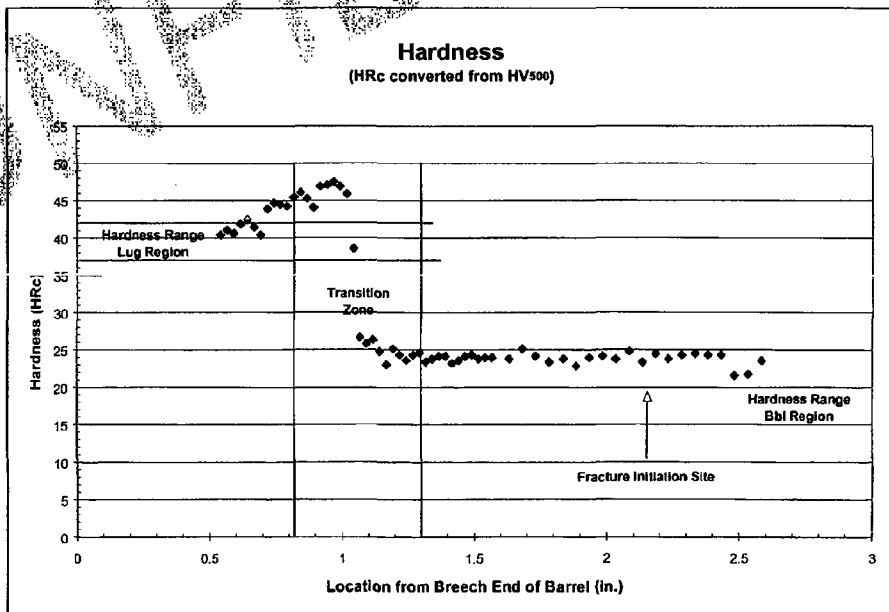
Figure 6 presents a graph of the barrel material hardness versus distance from the breech end of the barrel. The actual data points are plotted along with the design specification as indicated on the barrel print for the magnum barrel.

Figure 6. A graph of the barrel hardness versus distance from the breech end.

The hardness results indicate that the barrel was within the print specifications at the location of the failure. The hardness at the beginning of the transition zone is higher than the design specification hardness. This deviation had no impact on the failure of the barrel, based on the fracture origination location. This higher hardness is an indication that the tempering operation during manufacturing is not heating the barrel far enough into the breech end to fully temper back the quenched region. This issue, by itself, does not affect the destructive burst testing characteristics of the system.

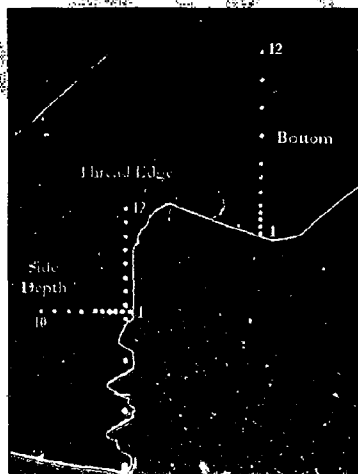
Figure 7 presents an image of the hardness indents that were performed around the fracture initiation site with each group of indents labeled. The hardness indents were performed utilizing the Vicker's scale with a 500g major load and then converted to HRc scale. The hardness specification in this location is a range of HRc 20-25. The material around the fracture origin was found to be within the design specification limits. Table 1 presents the hardness data.

The last several hardness points taken at the bottom of the takedown screw hole had slightly increased hardness values. This is most likely due to the deformation of the material at this location. The top of the image presented in Figure 7 is the chamber of the rifle.

Figure 7. An image of the micro-hardness indent locations around the fracture origin location. Each group of indents and the first and last indent number are labeled.

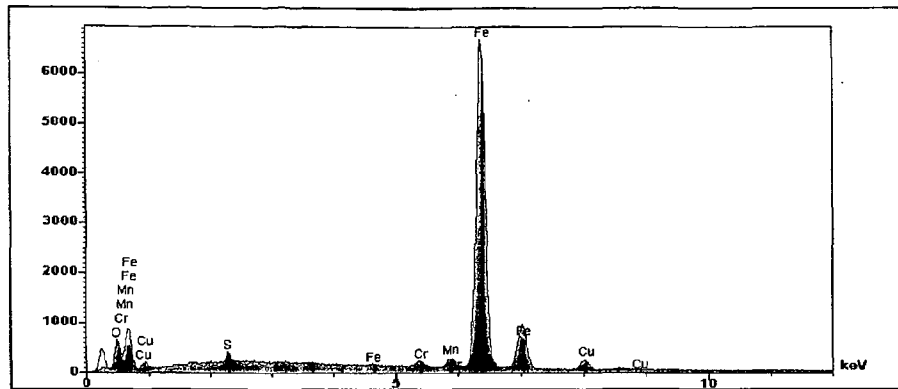
The fracture surface of the sample seemed to be covered with a light coating of material, evident by the soft edges of the ductile dimples. A qualitative EDX analysis was performed of this fracture surface and compared to a qualitative EDX analysis performed on the clean base material of this barrel. Figure 9 presents an image of the compared EDX spectrum obtained from each analysis.

Figure 9. A comparison of two EDX spectra. The red spectrum represents the fracture surface and the blue spectrum is the compared base material spectrum. The spectra have been normalized to the main Fe peak in the center of the graph.

The spectral comparison indicates that both materials have identical ratios of Fe, Mn, and Cr present. These materials are consistent with the AISI 4137 material used to fabricate the barrel. The fracture surface spectrum contains additions of Cu, O, and S. These are all combustion products and deposited material from the rifle shell case that was destroyed in the chamber during the test and accounts for the light coating of material on the fracture surface.
