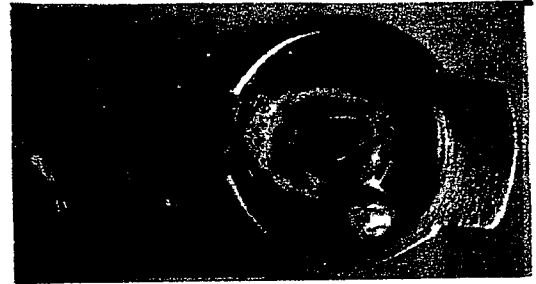
Fig. No. 10

- IX. • The second breakage occurred to the new bolt that was purchased for the 7mm Rem. Mag. rifle. When the new bolt was proofed, the bolt was rendered inoperable. The bolt had to be opened with a hammer. The extractor was broken and the extractor slot was bowed out, both sides. (The headspace measured on the new bolt before proof was min. $+.003"$.) (Fig. No. 10)

Win.M/70XTR
new bolt
proof rd.
8-18-81

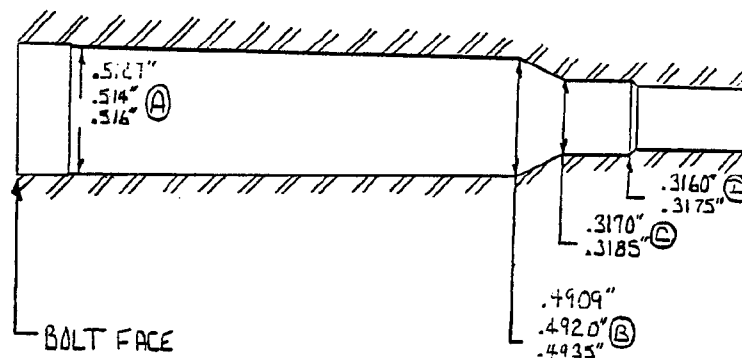
Fig. No. 117MM MAG. CHAMBER MEASUREMENTS

Two chamber casts were made after the rifle was disassembled. The measurements from the two casts, the actual fired proof round, an unfired factory round and the original chamber measurements taken at zero rounds are compared below. Fig. No. 11 is the Remington Chamber Drawing, and the figures in red are the SAAMI Recommended Min. Dimension.
