REMINGTON ARMS CO., INC.
Firearms Research Division

Report No. 832381
Page 1

REPORT TITLE: M/700 BDL LEFT HAND - EXTRA GAS RELIEF HOLE IN RECEIVER

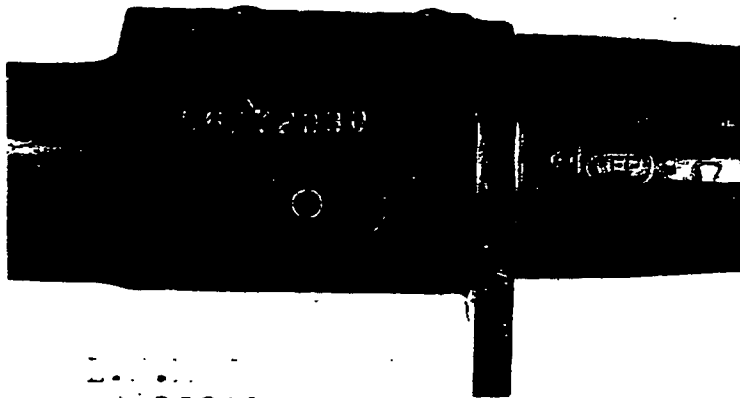
Picture 1

A small quantity of L. H. M/700 receivers were run in production with two gas relief holes in the front receiver ring, (See Appendix for pictures). The extra hole is hidden by the stock on the right side of the receiver. W. A. Warren, Quality Control Foreman, sent one L. H. M/700 BDL rifle in .270 caliber to the Lab to determine what effect the extra relief hole has on stock damage or shooter safety when a primer is pierced.

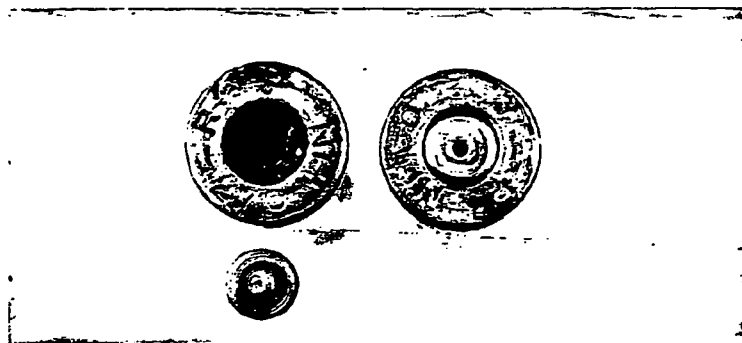
Picture 3

.270 proof
primers intentionally
pierced
