January 15, 1988

TRIGGER ASSEMBLY REPLACEMENT PROGRAM (TARP)

Remington Arms Company, Inc.

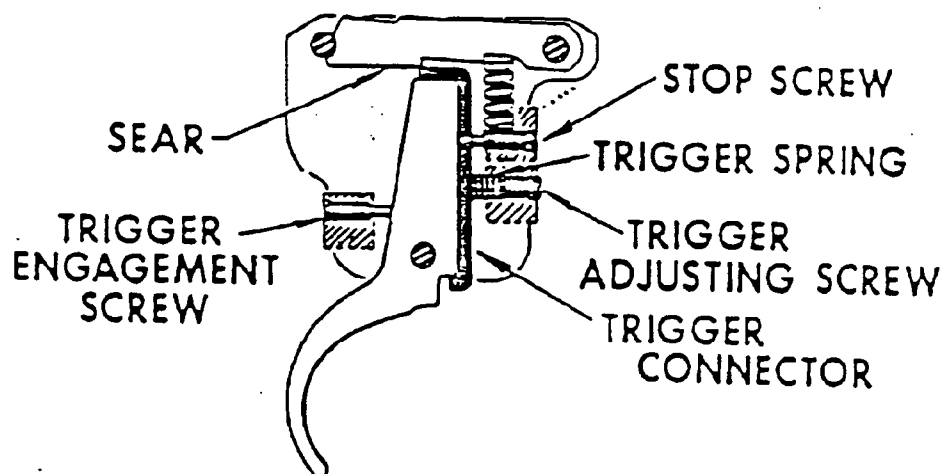
SECTION VIEW, MODEL 700 SERIES TRIGGER ASSEMBLY

The next step is to institute a general replacement program for those rifles that potentially could be impacted by the nonconforming connectors. Major elements of this program are discussed below:

8. About 40M extra trigger assemblies will be procured to handle the one-time effort associated with this program. Based on current estimates, it is more economical, practical, and safe to replace full assemblies rather than reconditioning assemblies. However, should a way of reconditioning be found that is more economical, practical, and safe, these parts ultimately may be used. The cost per assembly is about \$9.
