900011 Dry Cycle Bolt Handle
900081 Synthetic Stock Evaluation
900301 Shear & Endurance Sight Screw
900671 17 Cal. 4-Hit GFM
892831 Web Thickness Sight Holes

Report No. 900011

RESEARCH TEST & MEASUREMENT LAB WORK REQUEST

FAILURE MODES OF REMINGTON BOLT ACTION RIFLES

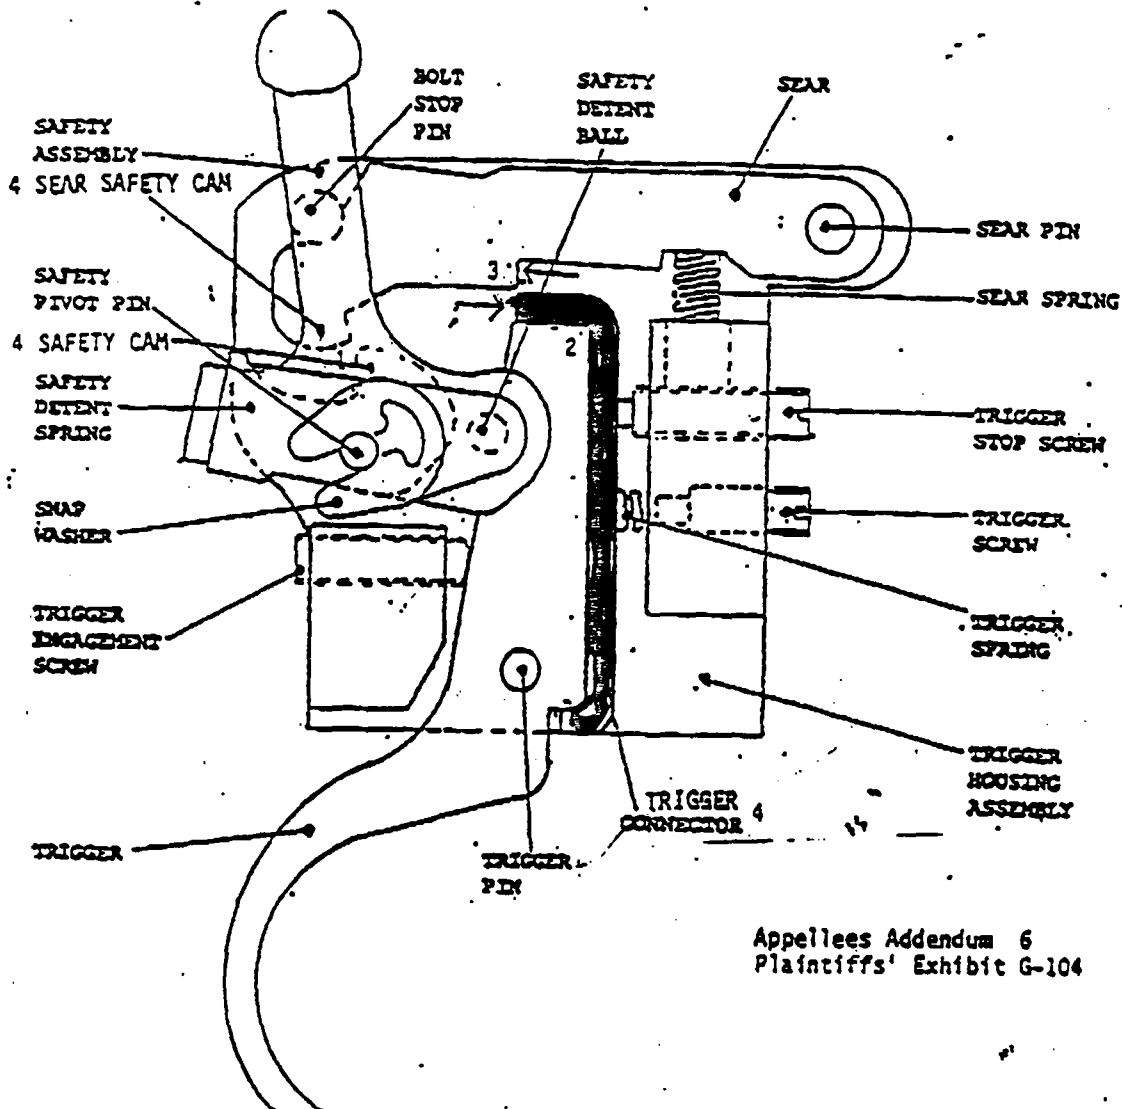
Appellees Addendum 6
Plaintiffs' Exhibit G-104

1. The safety cam rotates counterclockwise contacting the sear safety cam and lifting the sear from the trigger connector when the safety lever is moved forward to the on safe position. The sear lift in the Lewy rifle was .007 inches (T. 7/35).
2. This drawing does not show the vertical clearance between the trigger and trigger connector which was .010 inches in the Lewy rifle (T. 7/38).
3. The horizontal interference between the trigger connector and sear which was up to .003 (.010 - .007) inches in the Lewy rifle prevents the trigger connector from returning under the sear to provide support when the safety is moved to the off position (T. 8/52).
4. Appellees have added labels to G-104 in order to pictorially explain the function of the Walker fire control system and FSRs to the Court.

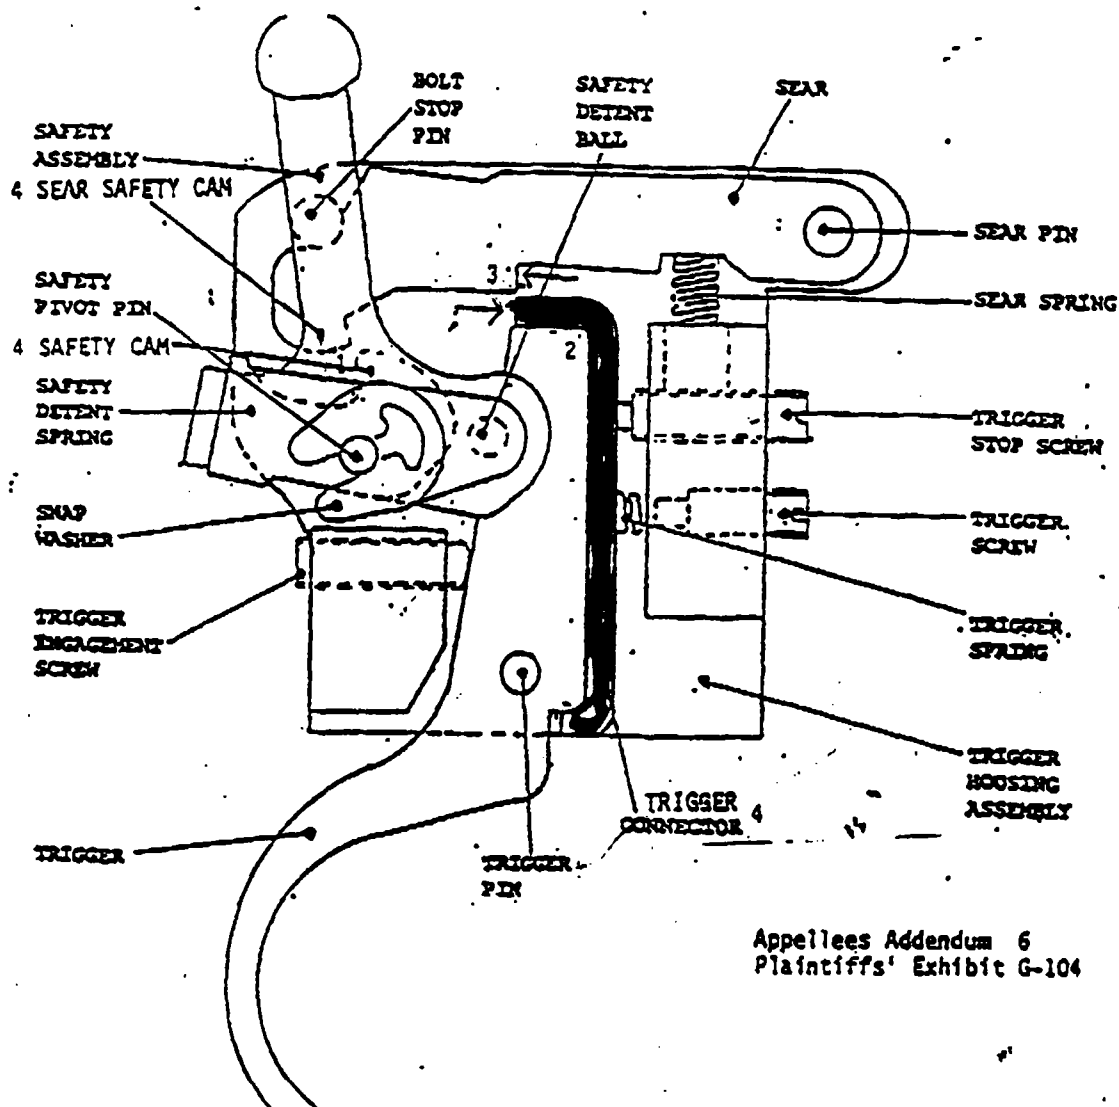
Appellees Addendum 6
Plaintiffs' Exhibit G-104

1. The safety cam rotates counterclockwise contacting the sear safety cam and lifting the sear from the trigger connector when the safety lever is moved forward to the on safe position. The sear lift in the Lewy rifle was .007 inches (T. 7/35).
2. This drawing does not show the vertical clearance between the trigger and trigger connector which was .010 inches in the Lewy rifle (T. 7/38).
3. The horizontal interference between the trigger connector and sear which was up to .003 (.010 -.007) inches in the Lewy rifle prevents the trigger connector from returning under the sear to provide support when the safety is moved to the off position (T. 8/52).
4. Appellees have added labels to G-104 in order to pictorially explain the function of the Walker fire control system and FSRs to the Court.
