# TLW2170

## INTERIM PROGRESS REPORT A

### 40X X-MARK PRO TRIGGER FRACTURE

### 40X XMP DAT (S/N: TA#12)

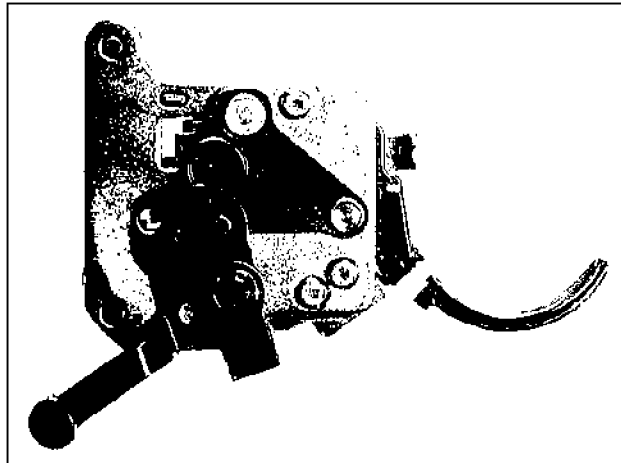
A trigger failure occurred during the measurement routine of the endurance testing portion of the DAT for the 40X X-Mark Pro fire-control conducted on March 28, 2007. Trigger assembly #12 (TA#12) was accidentally impacted against the measurement fixture which precipitated a failure of the trigger by fracture. At the time of failure, TA#12 had 500 rounds fired and was being utilized in test firearm A12. The measurements were being conducted by J. Ronkainen (Staff Engineer) using the optical comparator. When the trigger assembly was removed from the fixture, the trigger impacted the T-slot table fixturing of the optical comparator. This impact resulted in the fracture of the trigger. Figure 1 presents an image of the failed trigger assembly.

Figure 1. The failed TA#12 test sample.

TA#12 was removed from the DAT testing protocol. The DAT test was continued with TA#13 substituted for TA#12 for the remainder of the endurance testing. No other changes are planned for the remainder of the DAT. The failed trigger assembly was returned to J. Ronkainen.
