TLW2170

INTERIM PROGRESS REPORT B

40-X X-MARK PRO TRIGGER FAILURE

40-X XMP DAT (S/N: TA#17)

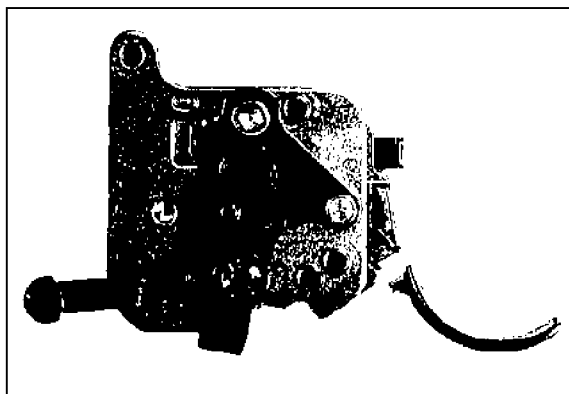
A trigger failure occurred during the dry cycle testing portion of the DAT for the 40-X X-Mark Pro (XMP) fire-control conducted on April 10, 2008. Trigger assembly #17 (TA#17) failed by fracture through the adjustment screw boss location on the trigger. The failure was found by Cody Greenwell (co-op student) as the fire-control was being transported to the measurement area to perform sear engagement measurements after 5,000 dry cycles had been completed. The trigger assembly was being transported in a box along with two additional trigger assemblies at the 5,000 cycle level. The trigger assembly was mounted onto a receiver (S/N S7607332) with the bolt in-place. When TA#17 was being removed from the box, C. Greenwell thought he felt some trigger movement on the trigger assembly. Upon inspection, the trigger failed with little-to-no pressure in his hand. Figure 1 presents an image of the failed trigger assembly. This failure location is identical to the failure of TA#12 which occurred by accidental impact during initial testing and measurement by J. Ronkainen on March 28, 2007.

Figure 1. the failed TA#17 test sample.

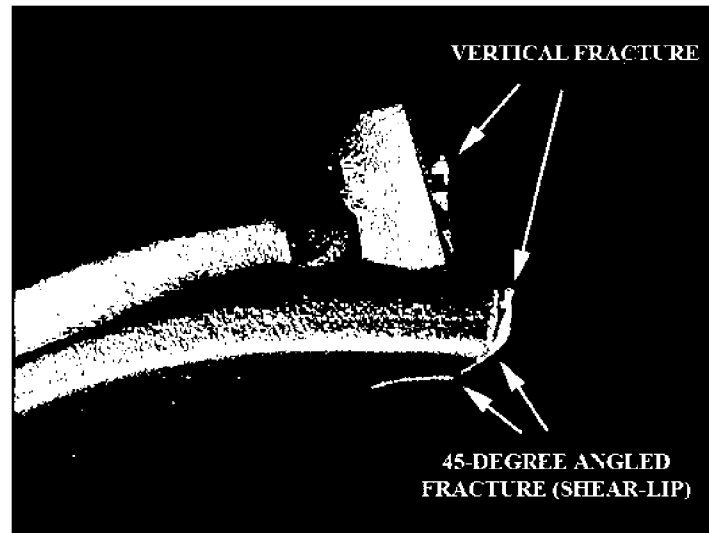
Figure 3 presents a close up image of the trigger bow portion of the fracture as viewed from the side angle. This image shows some fracture morphology characteristics which indicate the direction of fracture propagation. These features include a large area of straight (vertical) fracture and a small region of fracture which occurs at about 45° to the vertical fracture. This region is typically called a shear lip and represents the region of fracture in which the stress state changed from 3-dimensionally constrained to 2-dimensionally constrained – the last portion to fracture. This fracture path geometry indicates that the fracture initiated at the top of the boss or trigger bow and propagated to the bottom.

Figure 3. Side view of the trigger bow fracture. This image shows the change in direction of the fracture path, indicating the location of the shear lip at the final portion of the trigger bow to fracture.

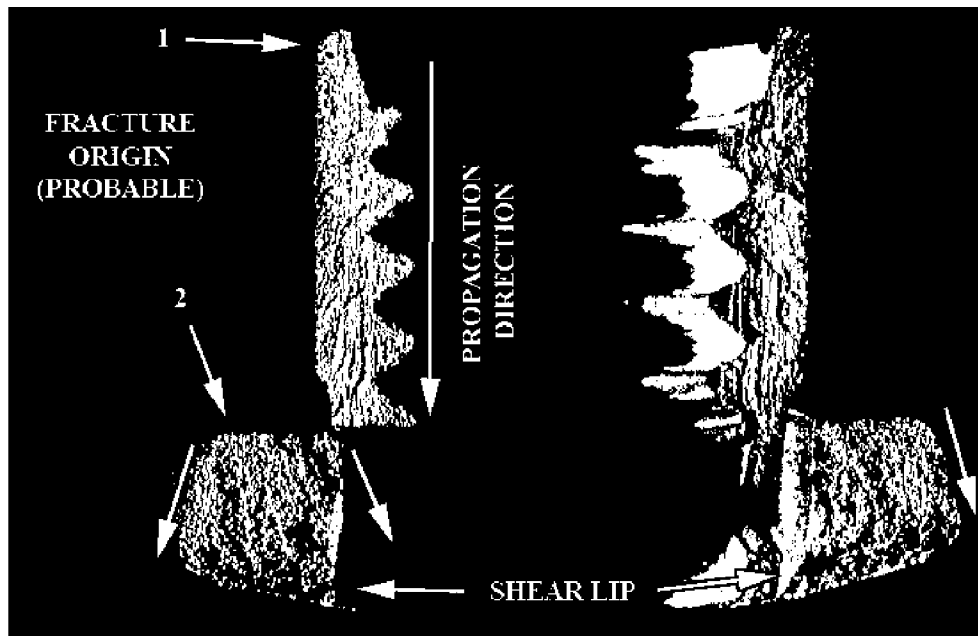
Figure 4 presents an image of the fracture surfaces as viewed with low-angle incident lighting. This image further confirms the evidence presented in Figure 3. The fracture propagated from the top surface of the boss and the top surface of the trigger bow cross section to the bottom of the trigger bow, ending at the shear lip region. The fracture initiation site is most likely one of two locations. The first probable location is the top of the trigger adjustment screw boss on the left side of the image presented as Figure 4. The second probable location is the top outer corner of the trigger bow cross section on the left side of the image presented as Figure 4.

Based on the direction of the fracture propagation, the load had to be applied to the rear of the trigger bow and applied in a forward direction. This orientation directly opposes the intended direction of force application to the trigger bow. Most likely, this failure occurred as a result of handling or abnormal loading the trigger mechanism.

Figure 4. The fracture surface of the failed trigger showing the fracture morphology of both the trigger bow region (lower edges with the shear lip) and the boss region (threaded portion).
