M/710 MAGNUM D.A.T.

BORE OBSTRUCTION TEST ORIGIN OF FAILURE REPORT

Prepared by:
Marlin R. Jiranek
Senior Research Engineer
September 29, 2003

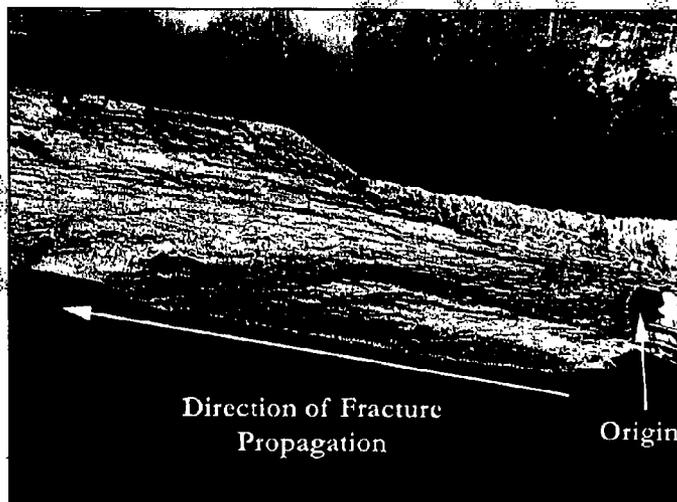
The chevrons are angled orientations on the fracture surface, which visibly appear to be "flow lines". These lines point to the fracture origin and are caused by the propagation of the fracture from its origin.

Figure 2. An image of the left side of the fracture initiation site.

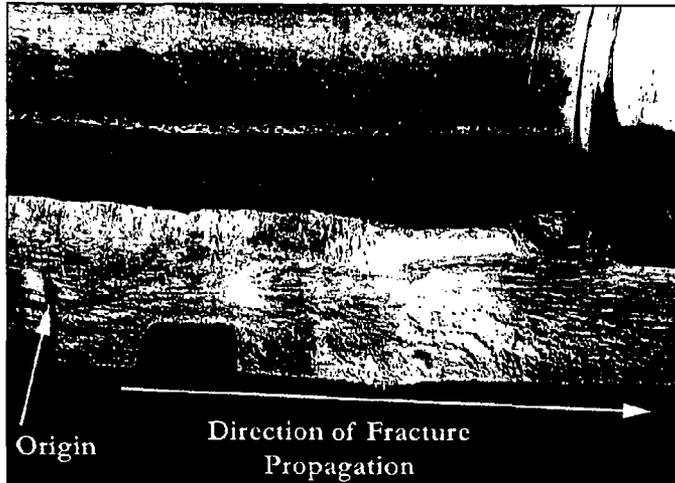
Figure 3. An image of the right side of the fracture initiation site.

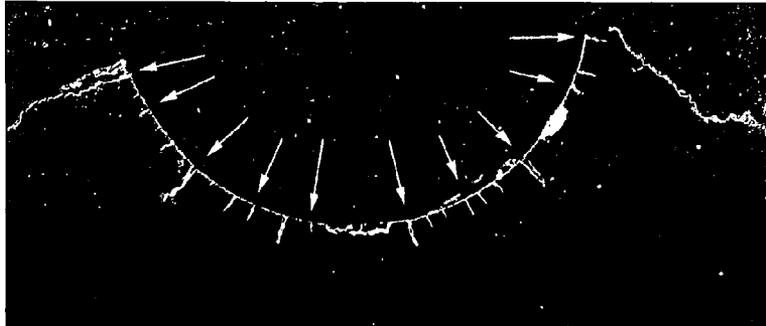
A sample cross section was taken from this region to determine the extent (depth) of the heat-check cracks. Figure 5 presents an image of the cross section of this heat-checked region and clearly depicts the crack depth. The deepest crack measured is

approximately 0.027". The effect on these cracks on the safety of the barrel is a function of crack propagation. This issue is addressed in the endurance portion of the D.A.T. testing and not of issue in this report because it did not have a role in the failure of this barrel.

Figure 5. An image of the cross section of the heat-checked region of the failed M/710 Magnum barrel.

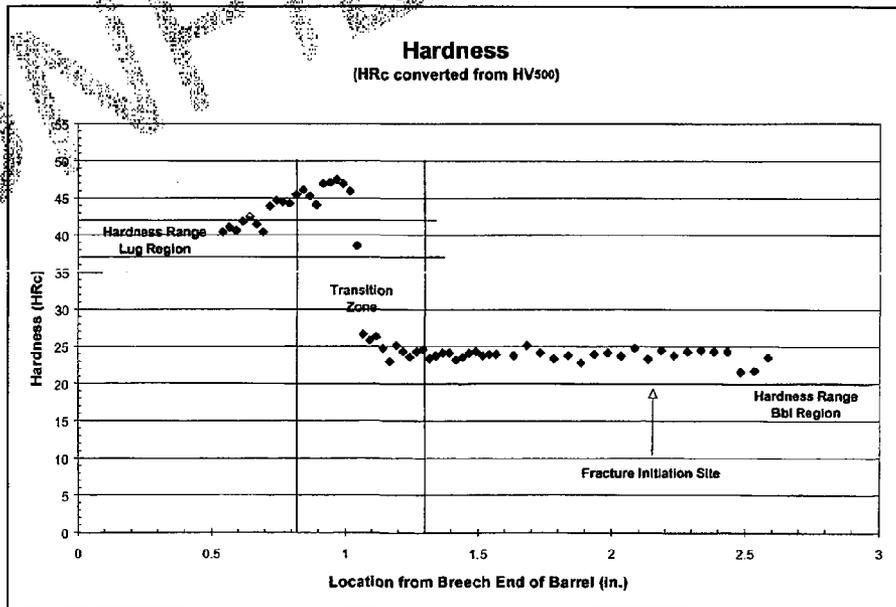
Figure 6. A graph of the barrel hardness versus distance from the breech end.

The hardness results indicate that the barrel was within the print specifications at the location of the failure. The hardness at the beginning of the transition zone is higher than the design specification hardness. This deviation had no impact on the failure of the barrel, based on the fracture origination location. This higher hardness is an indication that the tempering operation during manufacturing is not heating the barrel far enough into the breech end to fully temper back the quenched region. This issue, by itself, does not affect the destructive burst testing characteristics of the system.

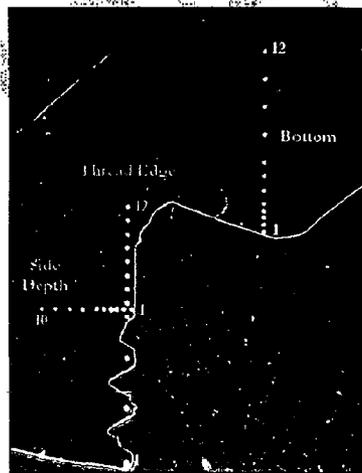
Figure 7 presents an image of the hardness indents that were performed around the fracture initiation site with each group of indents labeled. The hardness indents were performed utilizing the Vicker's scale with a 500g major load and then converted to HRC scale. The hardness specification in this location is a range of HRC 20-25. The material around the fracture origin was found to be within the design specification limits. Table 1 presents the hardness data.

The last several hardness points taken at the bottom of the takedown screw hole had slightly increased hardness values. This is most likely due to the deformation of the material at this location. The top of the image presented in Figure 7 is the chamber of the rifle.

Figure 7. An image of the micro-hardness indent locations around the fracture origin location. Each group of indents and the first and last indent number are labeled.

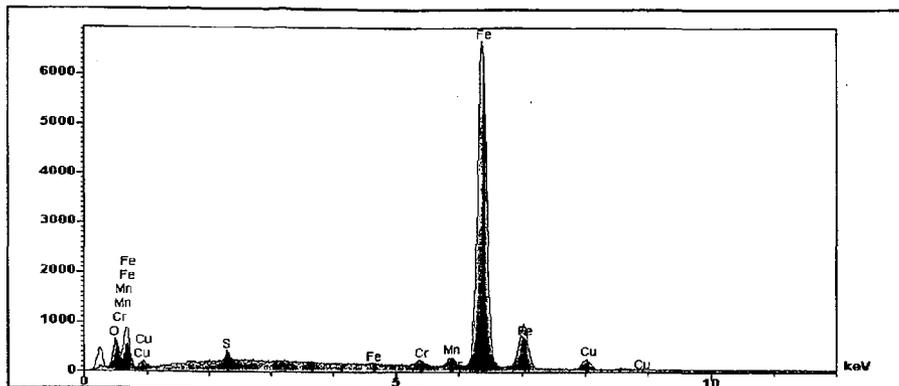
Figure 9. A comparison of two EDX spectra. The red spectrum represents the fracture surface and the blue spectrum is the compared base material spectrum. The spectra have been normalized to the main Fe peak in the center of the graph.

The spectral comparison indicates that both materials have identical ratios of Fe, Mn, and Cr present. These materials are consistent with the AISI 4137 material used to fabricate the barrel. The fracture surface spectrum contains additions of Cu, O, and S. These are all combustion products and deposited material from the rifle shell case that was destroyed in the chamber during the test and accounts for the light coating of material on the fracture surface.
