> Remington Arms Co., Inc. **Product Service** Legal Case #:9127

CONCERN:FSR

Remington/700/CF/BA

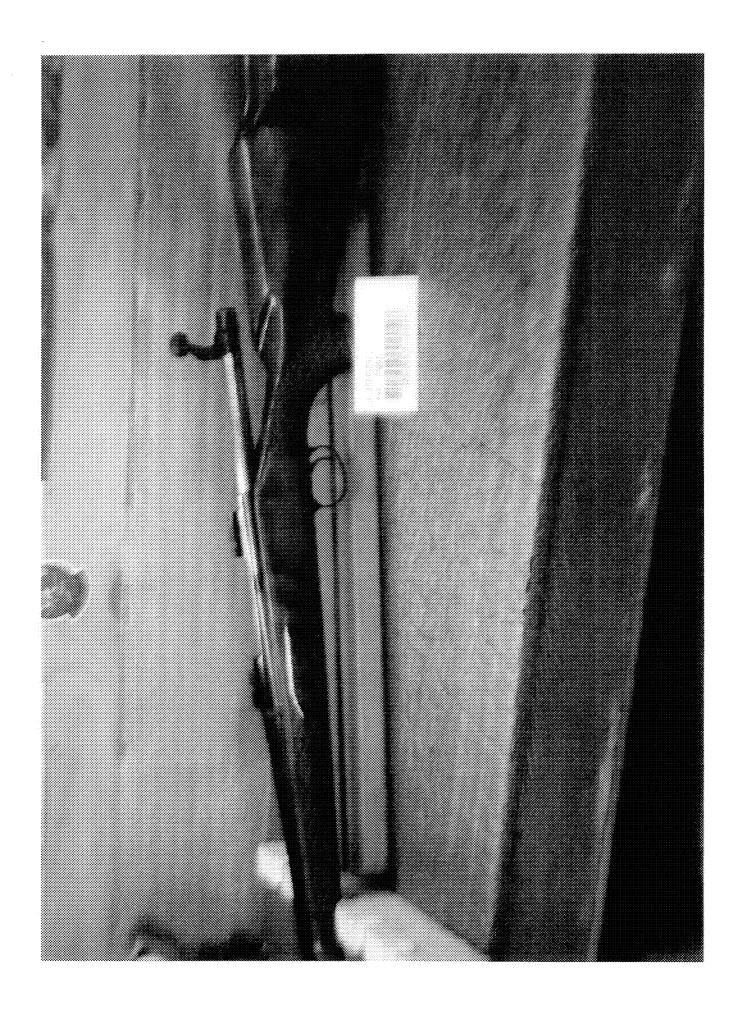
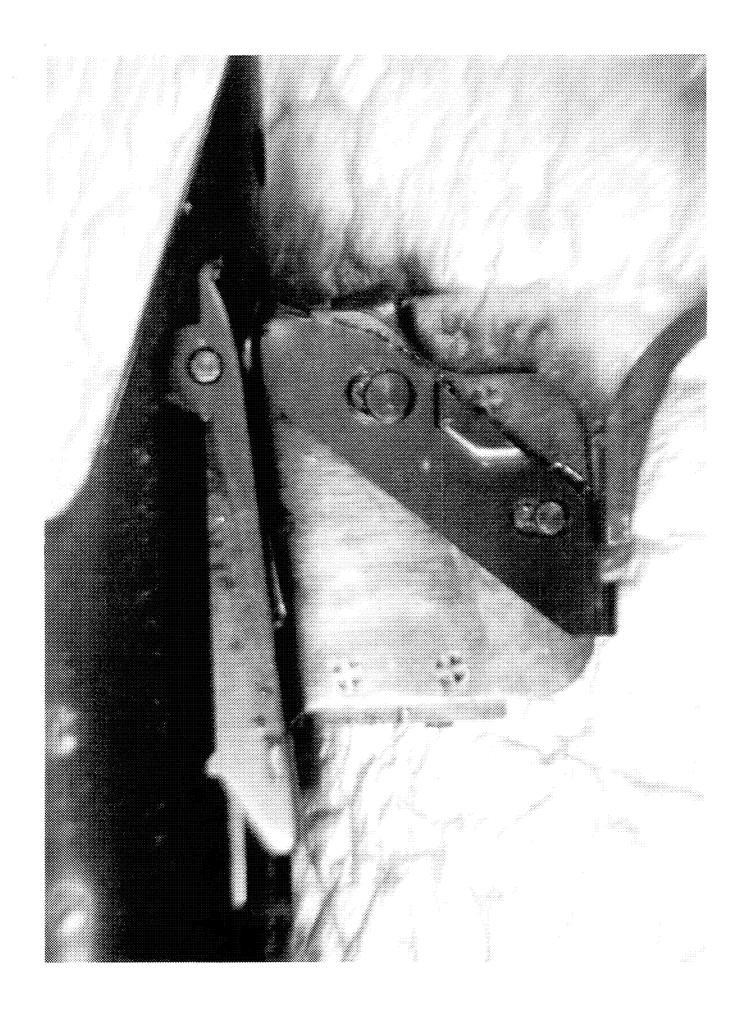
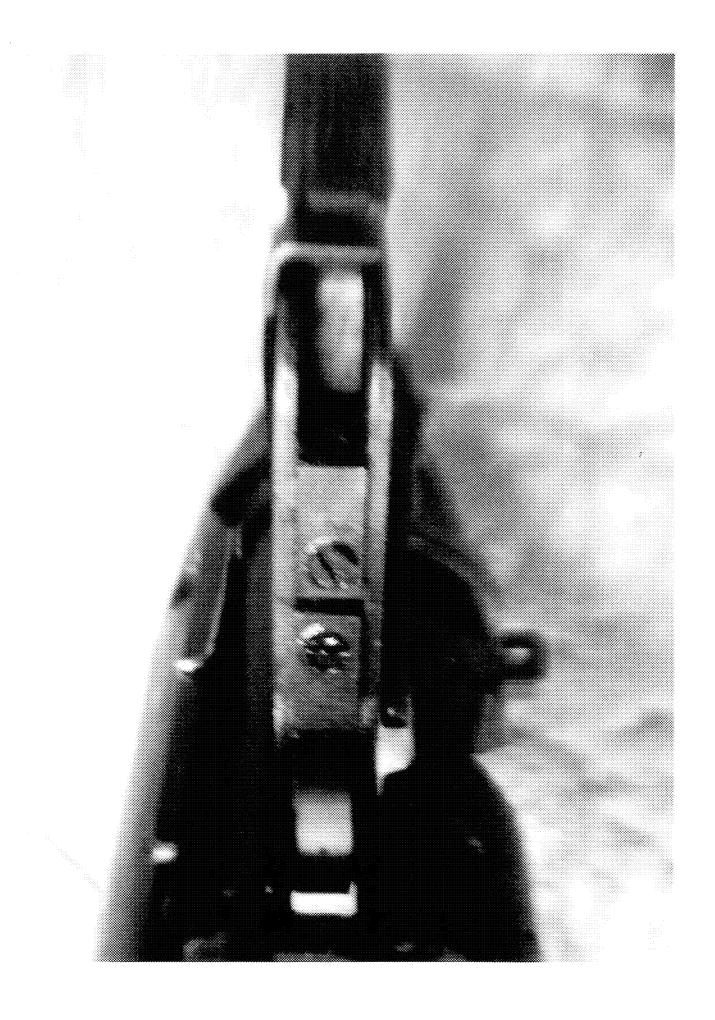
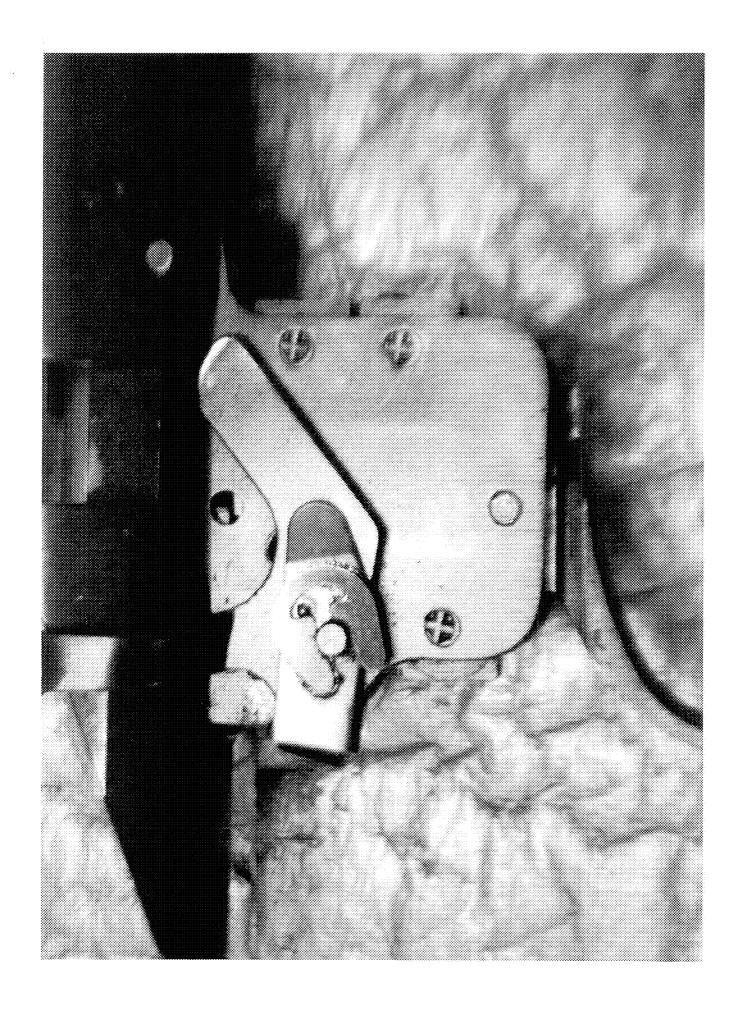
8/21/13: Per Ilion, "trigger assembly dirty, sticky & set screws altered, trigger is frozen to sideplates. Replace trigger assembly and test fire under bolt lock program for \$20.00 + shipping. Fit over size bolt to correct headspace at 25% discount." 8/22/13: I called Steven Hubnik and he approved the quote with a credit card. jbi

Sear	Lift	Select	.007	
	Notch	Slightly Worn; Functioning		
	Tools	Test Fired	False	
Feeding Test	Tests	False		
Trigger	Condition	Slightly Worn; Not Functioning	DIRTY STICKY.TRIG FROZEN TO SIDE PLATES	
	Pull	Select	10+# WOULD NOT MOVE	
	Altered	True	SEALANT MISSING	
	Sub-Assembly	M/700 Bolt Lock		
Non-Remington Components	Description		TWO PIECE BASE

Replace trigger assembly under BLP for \$20.00 + shipping and replace bolt at 25% discount
