File Number:	10955	Arms Service number:	9826050
Last Name:	LATIMER	First Name:	STEVE
Street:	RT 3 BOX 156-202	City:	STRAFFORD
State:	MO	Zip:	65757
Work Ph:		Home Ph:	
Type Concern:	S	Product Type:	F A T
	PI PD P S	Concern Code:	1020
Concern:	FIRED ON BOLT OPENING		
Cause Code:	4006	Cause:	ALTERED ADJUSTMENTS OR COMPONENTS
Assigned To:	SANITA	Classification:	UNJ UNJ UNC UND J
Settlement Detail:	REPAIR AT N/C REFUND REPAIR AND DEDUC	Settlement Amount:	\$390.0
Date Opened Rem:	12/02/1998	Date Opened by P/S:	12/03/1998
Date of Incident:		Caliber:	30/06
Date Closed:		Bullet Weight:	
Date to Analysis:		Date from Analysis:	
Manufacturer:	DREM		
Model:	700	Serial:	B6214744
Date Code:	KA	Date Mfgd:	05/01/1980
RAMAC:	700	Litigation:	<input type="checkbox"/>
PreLitigation:	<input type="checkbox"/>	Obsolete:	<input type="checkbox"/>
Custody:		Comments:	
Time of Modification:	7:42:58 AM	Date of Modification:	12/05/1998

RECEIVING AND ESTIMATING REPORT

DATE RECEIVED 12/02/98	DATE OPENED 12/04/98	DATE CODE KA 5-80	SERIAL NUMBER B6214744	NEW SERIAL NUMBER	MODEL AND GRADE 700 30-06	BDL
ACCESSORIES W/STUDS

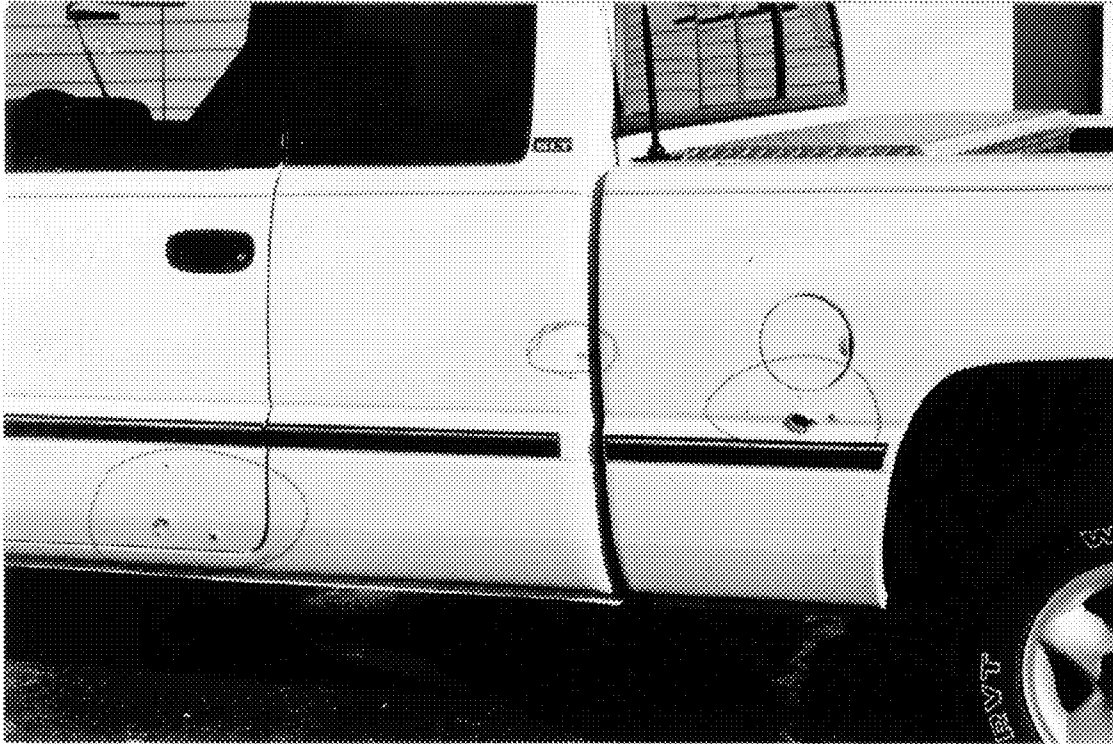
The enclosed rifle (Serial Number: B6214744) will fire while raising the bolt to remove the shell out of the chamber. I have taken it to a gunsmith for this particular reason and was told it was a broken spring. He replaced the spring and therefor, thought it was fixed. As you can see by the attached pictures, it is not fixed. Again, the rifle went off unexpectedly resulting in over \$2,000.00 of repair cost to my pick-up. It first hit the inside of the bed on the truck, exited through the outside of the bed, and then preceded to go through the driver's side door (the door was open when the gun went off).
