TLW2170
INTERIM PROGRESS REPORT A
40X X-MARK PRO TRIGGER FRACTURE
40X XMP DAT (S/N: TA#12)
Endurance Testing Measurement / Accidental Impact

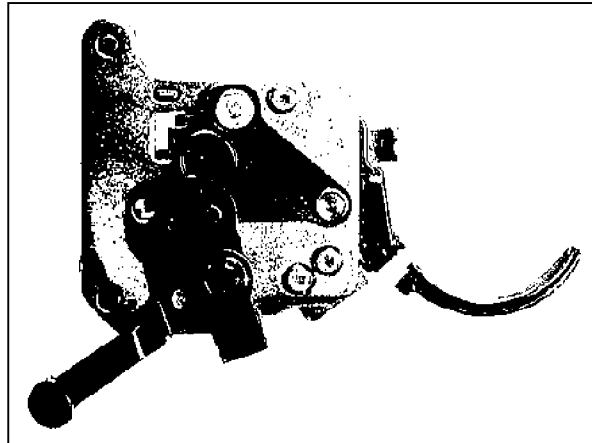
A trigger failure occurred during the measurement routine of the endurance testing portion of the DAT for the 40X X-Mark Pro fire-control conducted on March 28, 2007. Trigger assembly #12 (TA#12) was accidentally impacted against the measurement fixture which precipitated a failure of the trigger by fracture. At the time of failure, TA#12 had 500 rounds fired and was being utilized in test firearm A12. The measurements were being conducted by J. Ronkainen (Staff Engineer) using the optical comparator. When the trigger assembly was removed from the fixture, the trigger impacted the T-slot table fixturing of the optical comparator. This impact resulted in the fracture of the trigger. Figure 1 presents an image of the failed trigger assembly.

Figure 1. The failed TA#12 test sample.

The failure was a result of the impact of the trigger coupled with the geometry of the welded boss on the trigger. The welded boss created a notch that acted as a stress riser, at which the fracture initiated. In the production version, this weld will not be present; instead, the boss will be molded into the MIM trigger geometry without the presence of a notch. It should be noted also that the loading conditions which resulted in the failure are NOT typical of normal usage conditions for the trigger assembly. Most likely, this type of impact would not happen in the field due to the presence of the trigger guard on the assembled rifle.

TA#12 was removed from the DAT testing protocol. The DAT test was continued with TA#13 substituted for TA#12 for the remainder of the endurance testing. No other changes are planned for the remainder of the DAT. The failed trigger assembly was returned to J. Ronkainen.
