Benjamin Naiman, Capt.
25 Pinsker Str.
Petah-Tiqva, Israel.

Petah-Tiqva, March 30-th, 1956.

Remington Arms Company, Inc.
Ilion, N.Y., U.S.A.

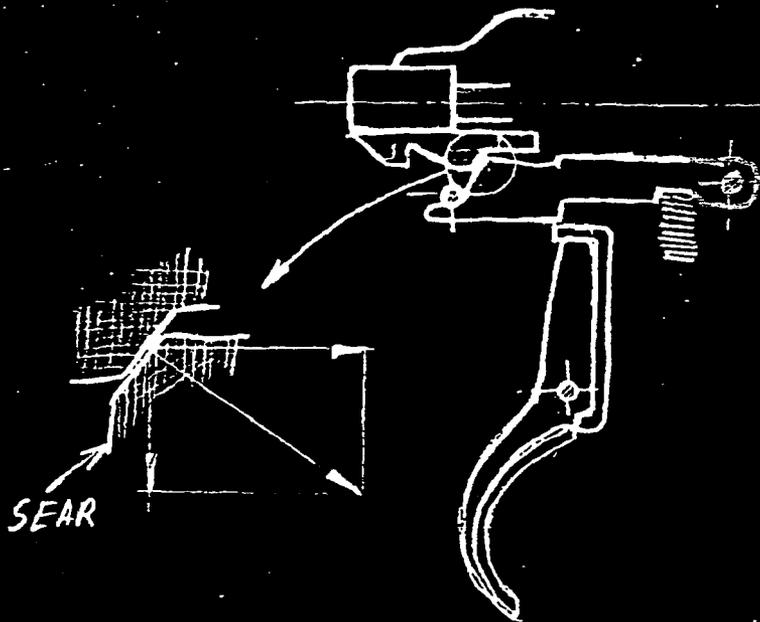
FIG 3

The disappointment came from the trigger action and here is the story: On the very day of the purchase, after several "dry shots" at home, the bolt got stuck and would not lock unless forced brutally. The safety lever would not function. The stock removed, the surface of the firing pin head was found to be riding over the sear surface. On further dismantling of the trigger mechanism, the cause was revealed: the trigger with the connector have sunk. I cannot state the cause; it was due, presumably to either the poor quality of the trigger alloy or to liberal tolerances (pins placings and such). Fig. No. 3 will illustrate the above.

POSITION ON MY RIFLE

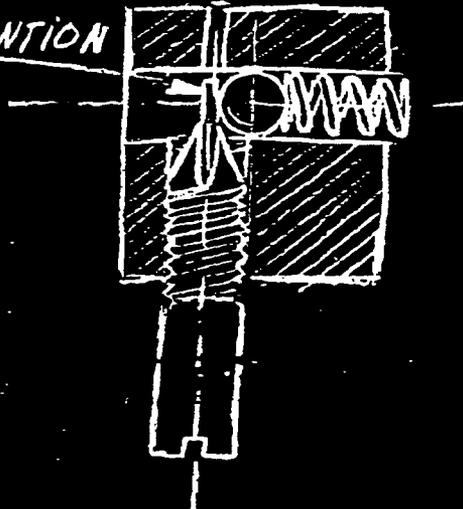
FIG 4

PIN EXTENTION

I had to order a new connector with a thicker head and, seeing no reason why it should not be connected to the trigger, I fixed the two bodies together by means of a 1/8" screw. The latter arrangement enabled me to replace the original heavy trigger spring by a lighter one aiming for a lighter pull. Please inform me whether you approve of the above. The click adjustment of the trigger is most convenient but unscrewing the trigger adjusting screw too much, causes the "trigger adjusting ball" to be pushed outside by the spring and removing of the stock becomes necessary. I suggest that the above be eliminated by addition of a thin pin-extension to the "trigger adjusting screw" (see fig. No.4). It proved successful on my rifle.
