Benjamin Naiman, Capt.  
25 Pinsker Str.  
Petah-Tiqva, Israel.

Petah-Tiqva, March 30-th, 1956.

Remington Arms Company, Inc.  
Ilion, N.Y., U.S.A.

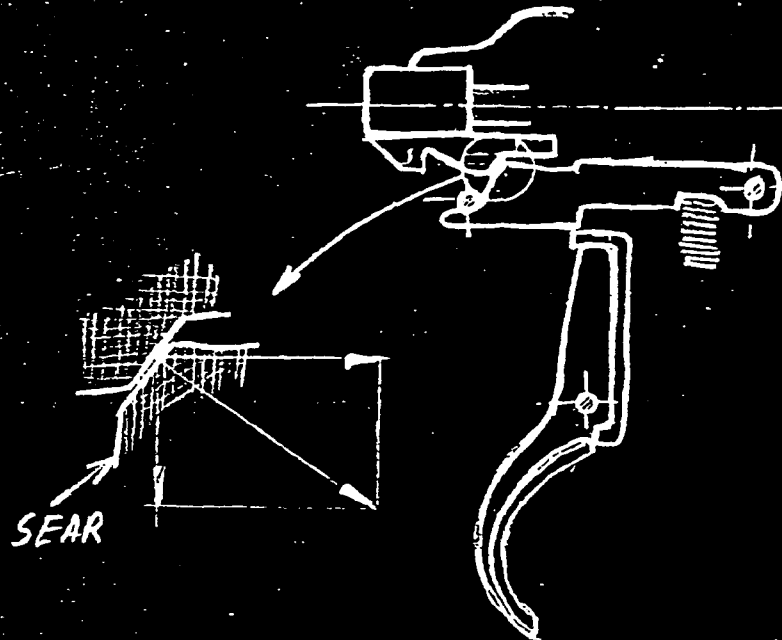
The disappointment came from the trigger action and here is the story: On the very day of the purchase, after several "dry shots" at home, the bolt got stuck and would not lock unless forced brutally.. The safety lever would not function. The stock removed, the surface of the firing pin head was found to be riding over the sear surface. On further dismantling of the trigger mechanism, the cause was revealed: the trigger with the connector have sunk. I cannot state the cause; it was due, presumably to either the poor quality of the trigger alloy or to liberal tolerances (pins placings and such). Fig. No. 3 will illustrate the above.

POSITION ON MY RIFLE

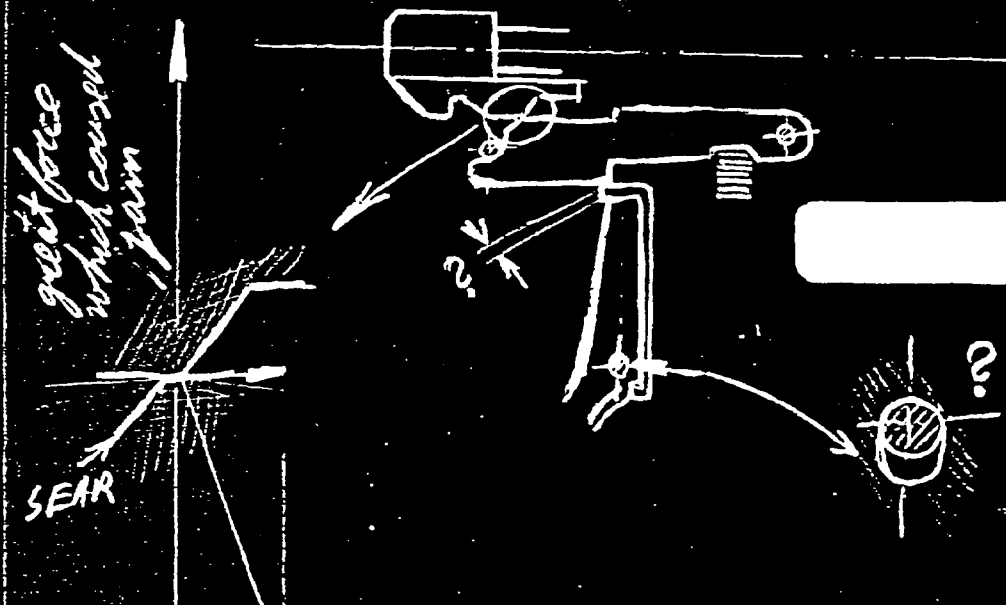
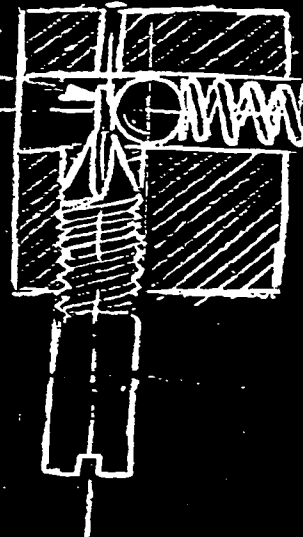
FIG 4

PIN EXTENTION

I had to order a new connector with a thicker head and, seeing no reason why it should not be connected to the trigger, I fixed the two bodies together by means of a 1/8" screw. The latter arrangement enabled me to replace the original heavy trigger spring by a lighter one aiming for a lighter pull. Please inform me whether you approve of the above. The click adjustment of the trigger is most convenient but unscrewing the trigger adjusting screw too much, causes the "trigger adjusting ball" to be pushed outside by the spring and removing of the stock becomes necessary. I suggest that the above be eliminated by addition of a thin pin-extension to the "trigger adjusting screw" (see fig. No.4). It proved successful on my rifle.
