REMINGTON ARMS COMPANY, INC.

TO: C. B. WORKMAN
FROM: A. A. HUGICK
DATE: JULY 17, 1979
SUBJECT: XP100 M. S. PISTOL DESIGN TEST
WORK ORDER: C 1804

To: C. B. Workman
From: A. A. Hugick
XP100 M. S. Pistol Design Test

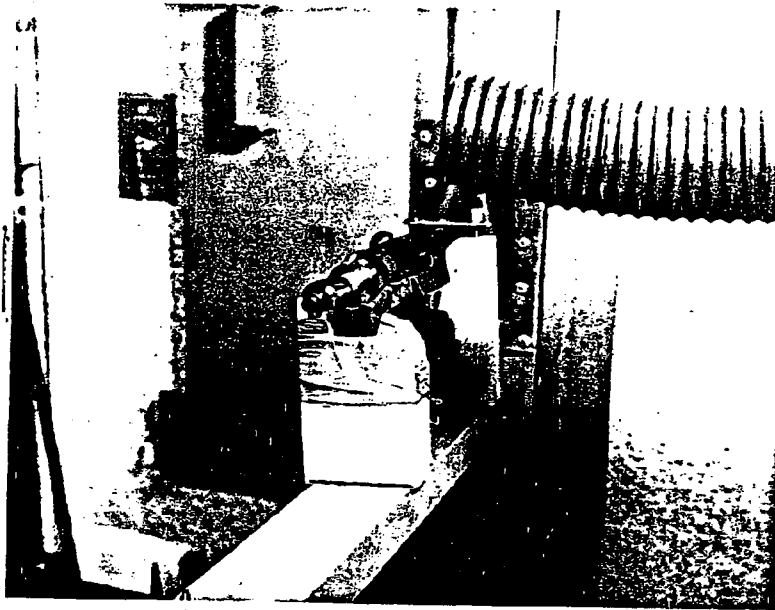
XP-100 Bolt Action Pistol caliber 308 Win. serial number B7505396 was fabricated for metallic silhouette pistol design test. Stock and recoil lug performance are two major items being design tested with introduction of larger caliber pistols for metallic silhouette competition. This endurance test shooting was fired from an improvised recoil rest fixture per attached photo firing R308WI.

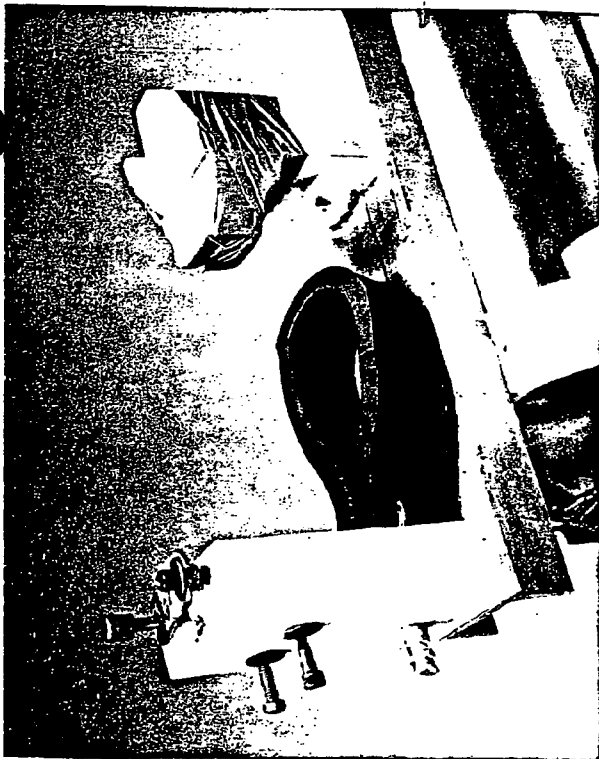
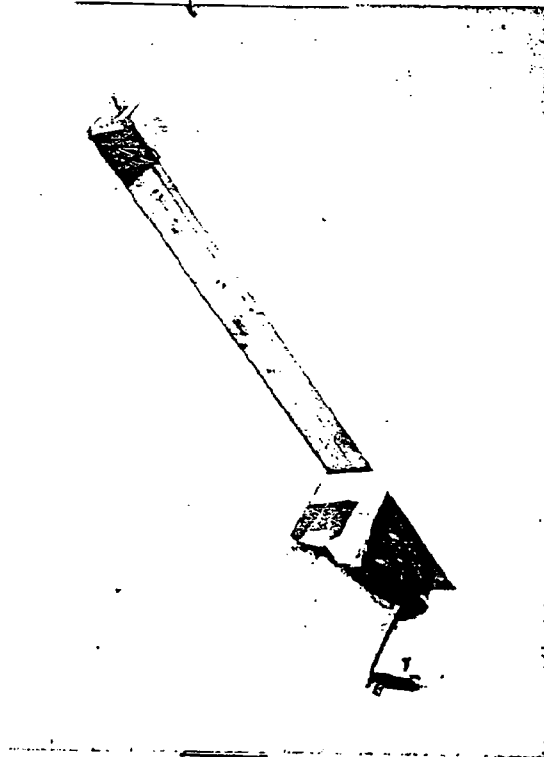
- 1) The XP-100 caliber 308 Win. S. N. B7505396 produced NO recoil lug bending in 3300 fired rounds of R308WI.
- 2) Sear lift and sear engagement measurements showed no significant change during this 3300 fired round test. See attached data sheet.
- 3) One stock assembly (No. 8) was test fired to five hundred (500) rounds of R308WI (150 Grain PSPCL) with acceptable results producing no detectable stock cracking or damage.
- 4) Three (3) stock assemblies, (No. 2, 3, 4) failed the escutcheon during this endurance test. February 1979 XP-100 test encountered similar escutcheon failures.
- 5) The escutcheon failure was located at the 1/32" R. Drawing location.

- 6) All test escutcheons appear to have sharp corners at this 1/32" R location.
- 7) Visual examination of escutcheon also indicated No. 8 - 36 NF-2 threads NOT TAPPED THROUGH the escutcheon.
- 8) Two stock assemblies (No. 1, No. 7) failed the weld joint of the stock, showing no weld along trigger guard and front of grip (internal and external).
- 9) Front sight base remained tight when screwed and epoxy mounted. (1300 Rounds) ²
- 10) Two stock assemblies (No. 5 and No. 6) failed when recoil rest fixture encountered failure during endurance shooting test.
- 11) The bolt handle joint failure resulted from contact with the recoil rest fixture.

- 1) XP-100 escutcheons with sharp corners lacking 1/32R. drawing specification be scrapped. Also desing considered increasing this drawing specification to a .050 R drawing specification.
- 2) Stock weld process be reviewed to eliminated partial welded joints as encountered in this endurance test.

These recommendations are made in view of the larger caliber XP-100 pistols increasing firing loads on firearm and out of specification parts and or assemblies will result in assembly failure.
