An investigation of the bolt revealed two probable causes:

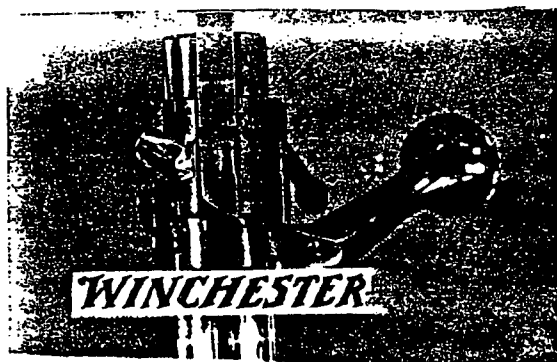
Fig. No. 9

- 2) The slot in the breech bolt sleeve is .010" oversized. This allows the firing pin head to be sloppy in the slot. This added to the cocking problem. (Fig. No. 9)
