# VISUAL INSPECTION

A-23

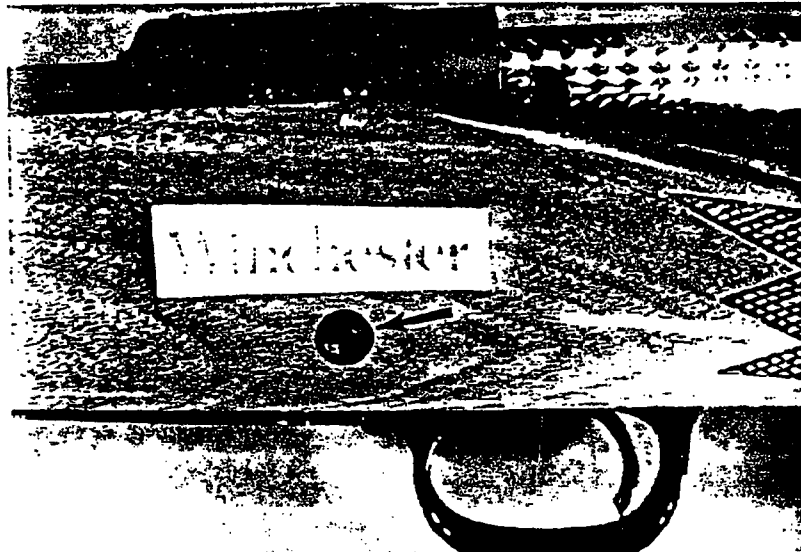
etch on  
rein-  
forcement pin.
