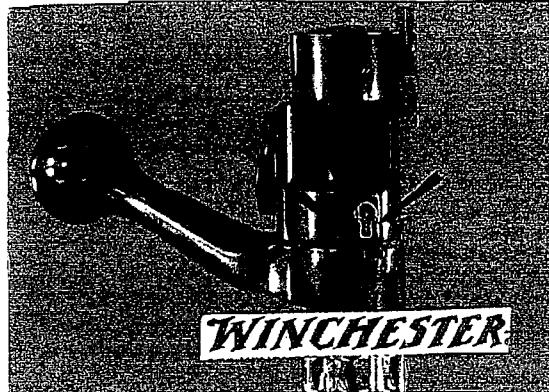
Fig. No. 8

- IX. An investigation of the bolt revealed two probable causes:
- 1) The bolt handle was brazed on .038" out of position. This causes the breech bolt sleeve lock to line up with the notch in the bolt handle in the wrong position, allowing the bolt to not fully cock. (Fig. No. 8)

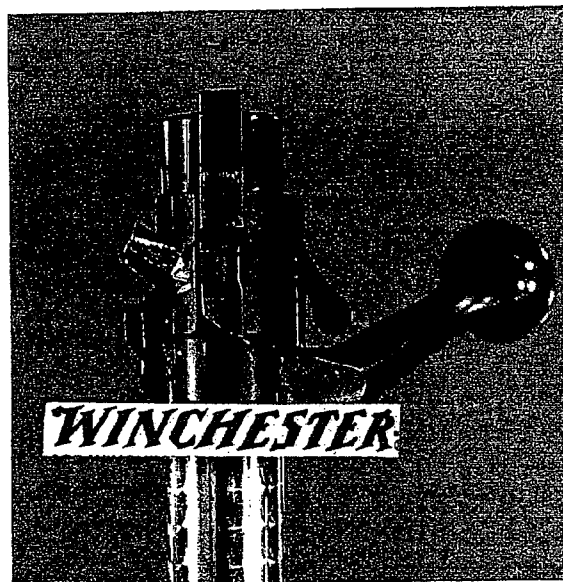
Fig. No. 9

- 2) The slot in the breech bolt sleeve is .010" oversized. This allows the firing pin head to be sloppy in the slot. This added to the cocking problem. (Fig. No. 9)
