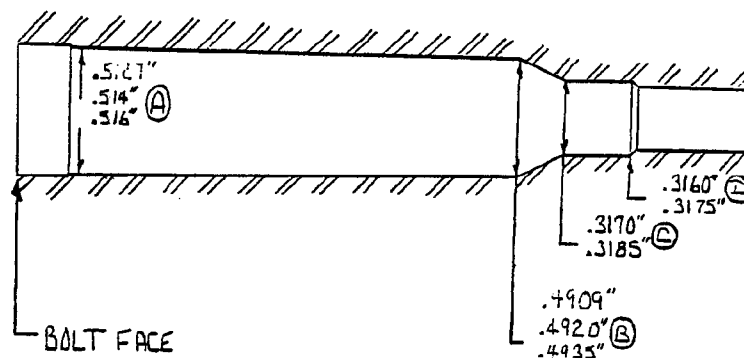
Two chamber casts were made after the rifle was disassembled. The measurements from the two casts, the actual fired proof round, an unfired factory round and the original chamber measurements taken at zero rounds are compared below. Fig. No. 11 is the Remington Chamber Drawing, and the figures in red are the SAAMI Recommended Min. Dimension.
