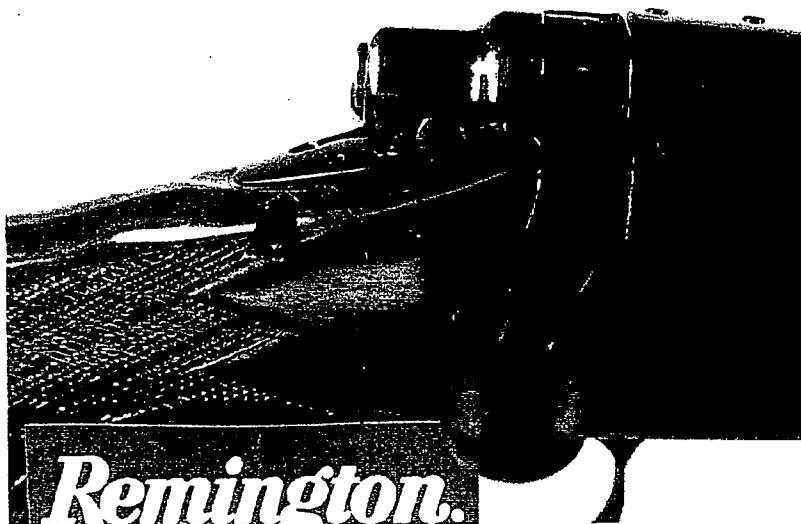
Rear Tang Not  
Flush with the  
Stock.
