3/8/63

To: CB workman  
From E.W. Yetter Jr.

Model Seven Floor Plate Latch

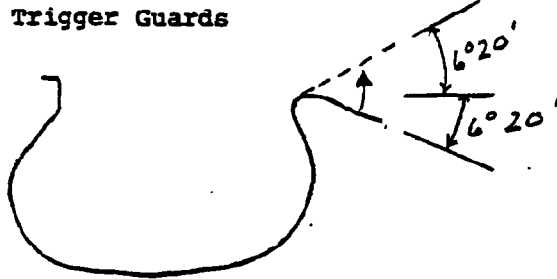
The downward force on the floor plate base from the trigger guard is caused by the  $6^{\circ}20'$  angle on the rear of the guard (see drawing). It was felt that if the trigger guard could be modified to change the direction of the force there would be enough additional support to the floor plate base to attenuate the vibrations that opened the latch. This was done by changing the angle on the rear of the trigger guard. Testing to date confirms this to be an adequate solution although there is sensitivity to certain other conditions such as the fit of the stock and the dimension of the latch spring.

- .062 thick Trigger Plate (.050-orig.)  
6 tested 3-F.P.O.s
- Double thick Trigger Plate (two standard plates together) 2 tested 0-F.P.O.s
- Stocks swapped. 4 guns tested  
F.P.O. problem followed Stock once
- Bent Trigger Guards

18 bad guns tested  
2 guns enduranced

16 were fixed  
500 rounds

1 - No Problem  
1 - F.P.O.s began 160 rounds  
Trigger Guard had bent back
