RESEARCH TEST & MEASUREMENT LAB WORK REQUEST

TEST AND MEASUREMENT LAB TEST RESULTS

FAILURE MODES OF REMINGTON BOLT ACTION RIFLES

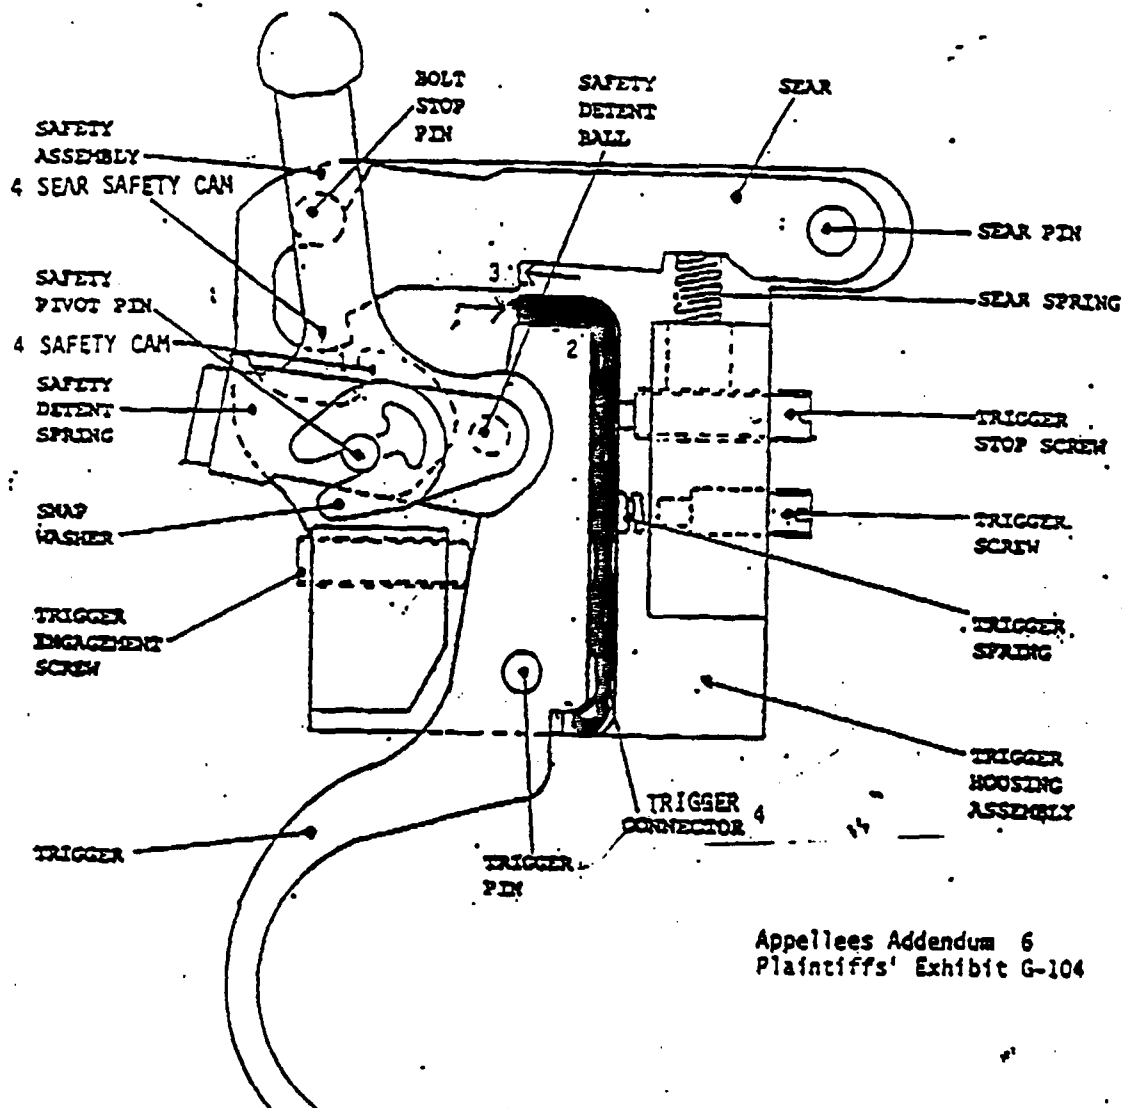
Appellees Addendum 6
Plaintiffs' Exhibit G-104

1. The safety cam rotates counterclockwise contacting the sear safety cam and lifting the sear from the trigger connector when the safety lever is moved forward to the on safe position. The sear lift in the Lewy rifle was .007 inches (T. 7/35).
2. This drawing does not show the vertical clearance between the trigger and trigger connector which was .010 inches in the Lewy rifle (T. 7/38).
3. The horizontal interference between the trigger connector and sear which was up to .003 (.010 - .007) inches in the Lewy rifle prevents the trigger connector from returning under the sear to provide support when the safety is moved to the off position (T. 8/52).
4. Appellees have added labels to G-104 in order to pictorially explain the function of the Walker fire control system and FSRs to the Court.

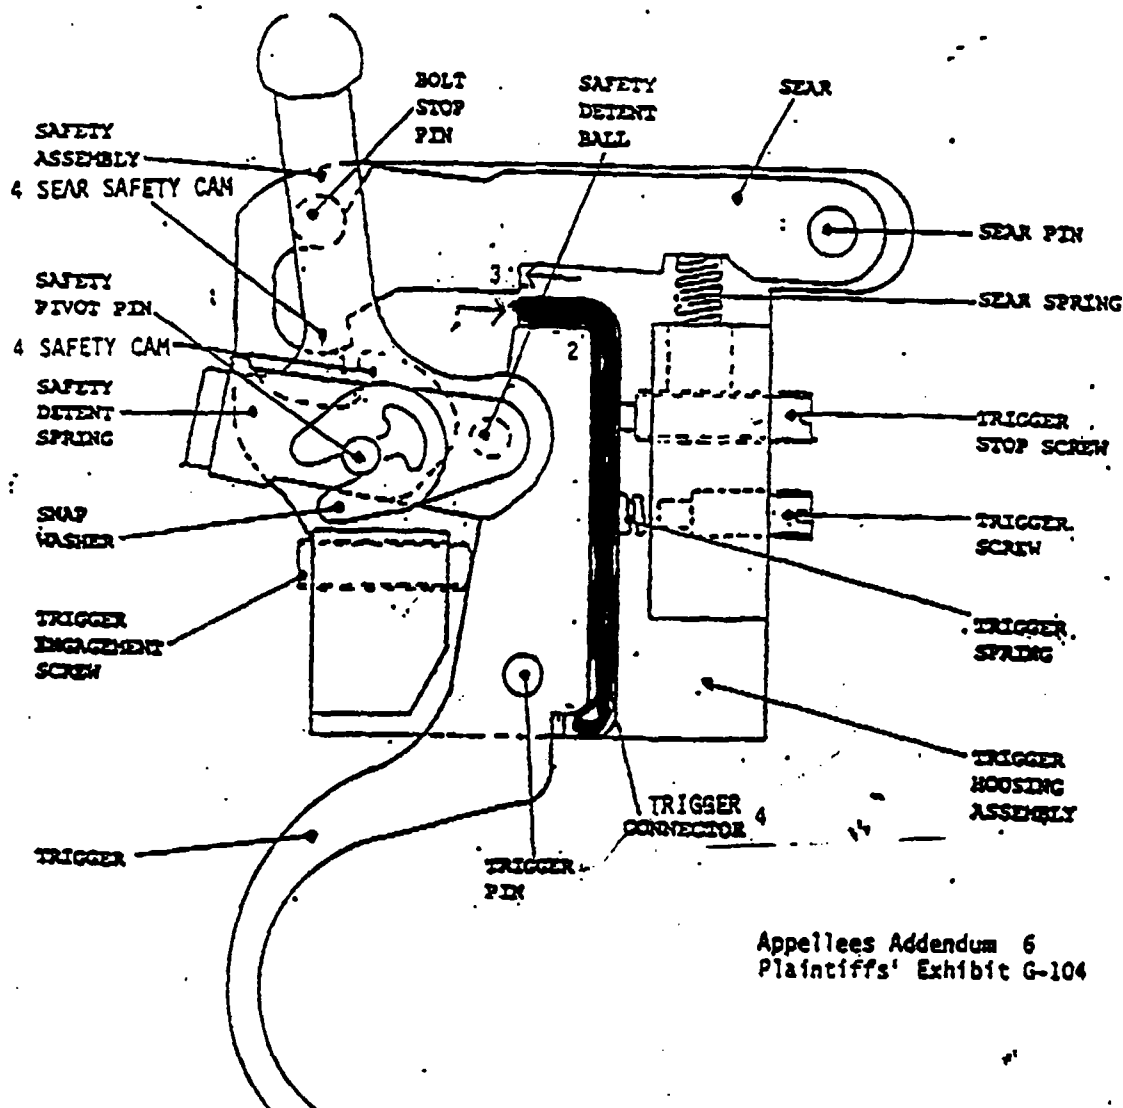
Appellees Addendum 6
Plaintiffs' Exhibit G-104

1. The safety cam rotates counterclockwise contacting the sear safety cam and lifting the sear from the trigger connector when the safety lever is moved forward to the on safe position. The sear lift in the Lewy rifle was .007 inches (T. 7/35).
2. This drawing does not show the vertical clearance between the trigger and trigger connector which was .010 inches in the Lewy rifle (T. 7/38).
3. The horizontal interference between the trigger connector and sear which was up to .003 (.010 -.007) inches in the Lewy rifle prevents the trigger connector from returning under the sear to provide support when the safety is moved to the off position (T. 8/52).
4. Appellees have added labels to G-104 in order to pictorially explain the function of the Walker fire control system and FSRs to the Court.
