**TLW2170**  
**INTERIM PROGRESS REPORT B**  
**40-X X-MARK PRO TRIGGER FAILURE**  
**40-X XMP DAT (S/N: TA#17)**  
**Endurance Dry-Cycle Testing**

**DESCRIPTION**

April 12, 2007  
TLW2170 Project 241460

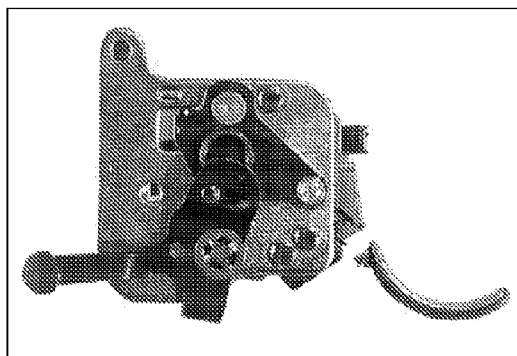
A trigger failure occurred during the dry cycle testing portion of the DAT for the 40-X X-Mark Pro (XMP) fire-control conducted on April 10, 2008. Trigger assembly #17 (TA#17) failed by fracture through the adjustment screw boss location on the trigger. The failure was found by Cody Greenwell (co-op student) as the fire-control was being transported to the measurement area to perform sear engagement measurements after 5,000 dry cycles had been completed. The trigger assembly was being transported in a box along with two additional trigger assemblies at the 5,000 cycle level. The trigger assembly was mounted onto a receiver (S/N S7607332) with the bolt in-place. When TA#17 was being removed from the box, C. Greenwell thought he felt some trigger movement on the trigger assembly. Upon inspection, the trigger failed with little-to-no pressure in his hand. Figure 1 presents an image of the failed trigger assembly. This failure location is identical to the failure of TA#12 which occurred by accidental impact during initial testing and measurement by J. Ronkainen on March 28, 2007.

Figure 1. the failed TA#17 test sample.

TA#17 was removed from the DAT dry cycle testing protocol. The DAT was continued with TA#20 substituted for TA#17 for the remainder of the test. All testing previously completed on TA#17 will be repeated on TA#20.

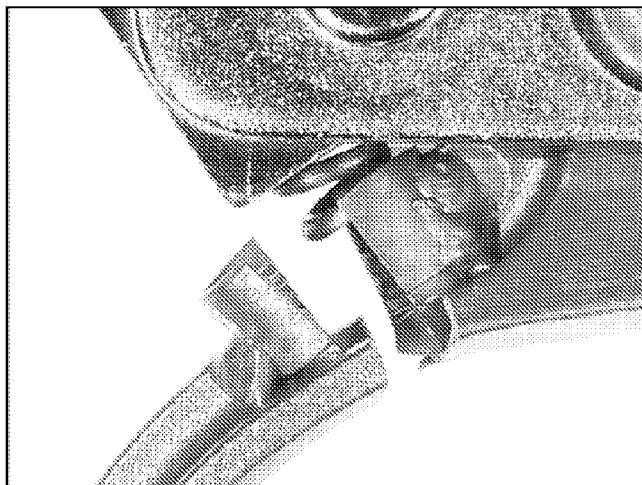
Figure 2 presents an increased magnification image of the fracture region of the trigger assembly. For clarity, the spring adjustment screw has been removed from the failed trigger assembly. This image presents the specific location of the fracture through the trigger bow and the trigger spring adjustment screw boss. In these prototype parts being used for the DAT test, the trigger boss is welded onto the trigger bow. The actual production trigger will have a molded-in boss which is drilled and tapped rather than a welded boss.

Figure 2. A close-up view of the fracture area with the trigger spring adjustment screw removed.

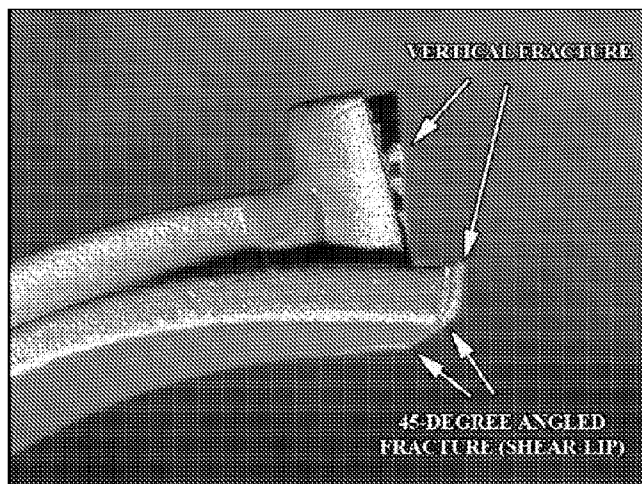
Figure 3 presents a close up image of the trigger bow portion of the fracture as viewed from the side angle. This image shows some fracture morphology characteristics which indicate the direction of fracture propagation. These features include a large area of straight (vertical) fracture and a small region of fracture which occurs at about 45° to the vertical fracture. This region is typically called a shear lip and represents the region of fracture in which the stress state changed from 3-dimensionally constrained to 2-dimensionally constrained – the last portion to fracture. This fracture path geometry indicates that the fracture initiated at the top of the boss or trigger bow and propagated to the bottom.

Based on the direction of the fracture propagation, the load had to be applied to the rear of the trigger bow and applied in a forward direction. This orientation directly opposes the intended direction of force application to the trigger bow. Most likely, this failure occurred as a result of handling or abnormal loading the trigger mechanism.

Figure 3. Side view of the trigger bow fracture. This image shows the change in direction of the fracture path, indicating the location of the shear lip at the final portion of the trigger bow to fracture.

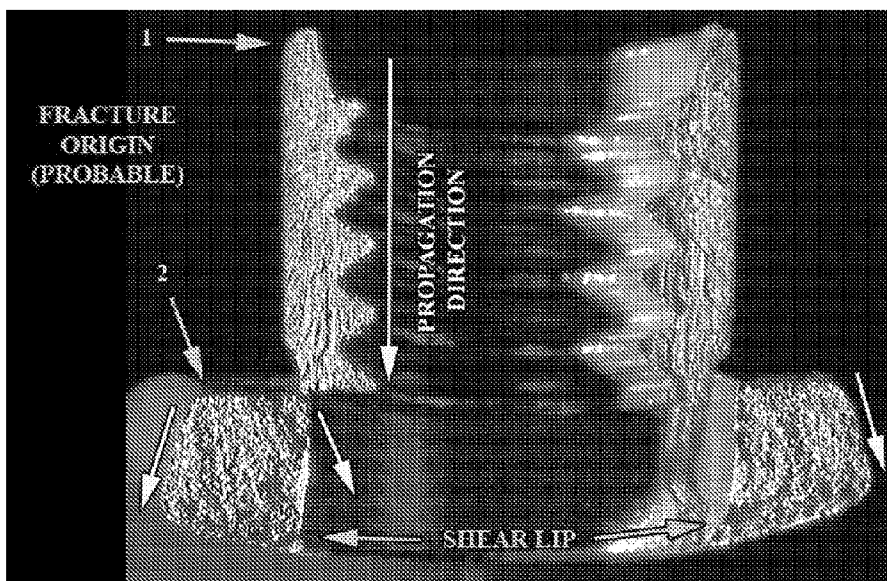
Figure 4 presents an image of the fracture surfaces as viewed with low-angle incident lighting. This image further confirms the evidence presented in Figure 3. The fracture propagated from the top surface of the boss and the top surface of the trigger bow cross section to the bottom of the trigger bow, ending at the shear lip region. The fracture initiation site is most likely one of two locations. The first probable location is the top of the trigger adjustment screw boss on the left side of the image presented as Figure 4. The second probable location is the top outer corner of the trigger bow cross section on the left side of the image presented as Figure 4.

Figure 4. The fracture surface of the failed trigger showing the fracture morphology of both the trigger bow region (lower edges with the shear lip) and the boss region (threaded portion).
