**TLW2170**  
**INTERIM PROGRESS REPORT A**  
**40X X-MARK PRO TRIGGER FRACTURE**  
**40X XMP DAT (S/N: TA#12)**  
**Endurance Testing Measurement / Accidental Impact**

March 29, 2007  
TLW2170 Project 241460

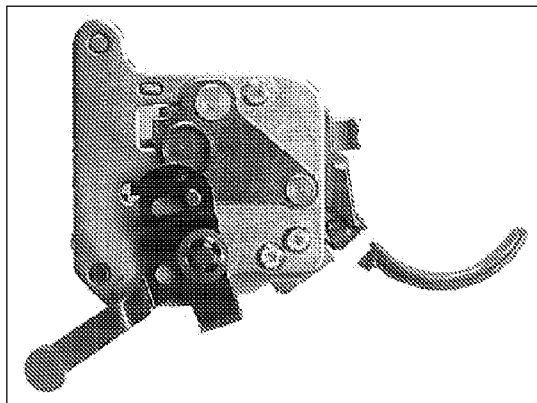
A trigger failure occurred during the measurement routine of the endurance testing portion of the DAT for the 40X X-Mark Pro fire-control conducted on March 28, 2007. Trigger assembly #12 (TA#12) was accidentally impacted against the measurement fixture which precipitated a failure of the trigger by fracture. At the time of failure, TA#12 had 500 rounds fired and was being utilized in test firearm A12. The measurements were being conducted by J. Ronkainen (Staff Engineer) using the optical comparator. When the trigger assembly was removed from the fixture, the trigger impacted the T-slot table fixturing of the optical comparator. This impact resulted in the fracture of the trigger. Figure 1 presents an image of the failed trigger assembly.

Figure 1. The failed TA#12 test sample.

TA#12 was removed from the DAT testing protocol. The DAT test was continued with TA#13 substituted for TA#12 for the remainder of the endurance testing. No other changes are planned for the remainder of the DAT. The failed trigger assembly was returned to J. Ronkainen.

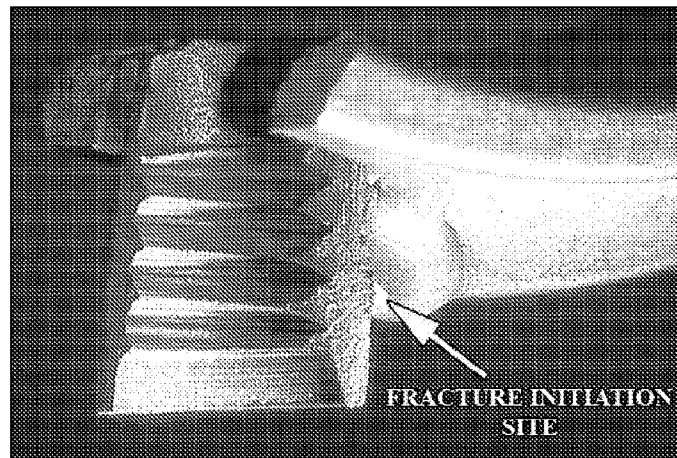
Figure 2 presents an image of the fracture surface of the trigger bow with the fracture initiation site identified. The fracture initiated at the outside surface of the screw boss at a notch created by the intersection of the weld bead and the trigger adjustment screw boss. Figure 3 presents a side-view image of the failed trigger at the fracture initiation site location. This image provides an illustration of the notch created between the weld bead and the trigger adjustment screw boss. In the production design, the trigger adjustment screw boss will be molded into the trigger geometry and the weld bead will not be required. This will eliminate the potential of a notch existing and minimize any stress risers at this location on the trigger.

Figure 2. The fracture surface of the failed trigger showing the location of the fracture initiation.

The failure was a result of the impact of the trigger coupled with the geometry of the welded boss on the trigger. The welded boss created a notch that acted as a stress riser, at which the fracture initiated. In the production version, this weld will not be present; instead, the boss will be molded into the MIM trigger geometry without the presence of a notch. It should be noted also that the loading conditions which resulted in the failure are NOT typical of normal usage conditions for the trigger assembly. Most likely, this type of impact would not happen in the field due to the presence of the trigger guard on the assembled rifle.

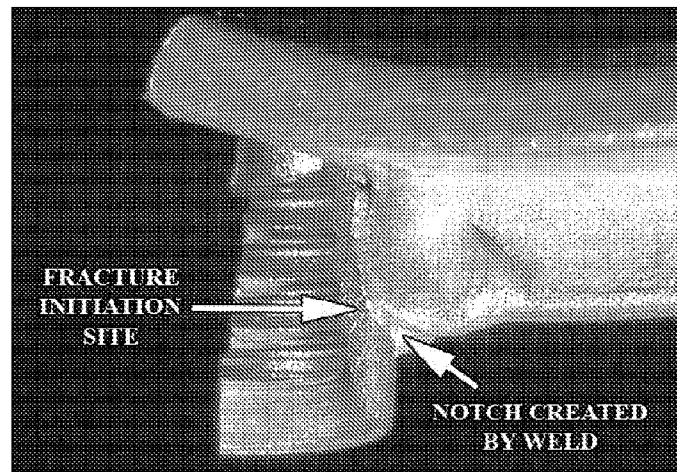
Figure 3. A side-view of the fractured trigger showing the location of the fracture initiation site relative to the notch created between the weld bead and the trigger adjustment screw boss.
