**REMINGTON ARMS COMPANY INC.
ILION, NY PLANT SITE**

**TECHNICAL DIVISION
TEST & MEASUREMENTS LAB**

TEST REPORT

Model Seven XMP Trigger Assembly T&P

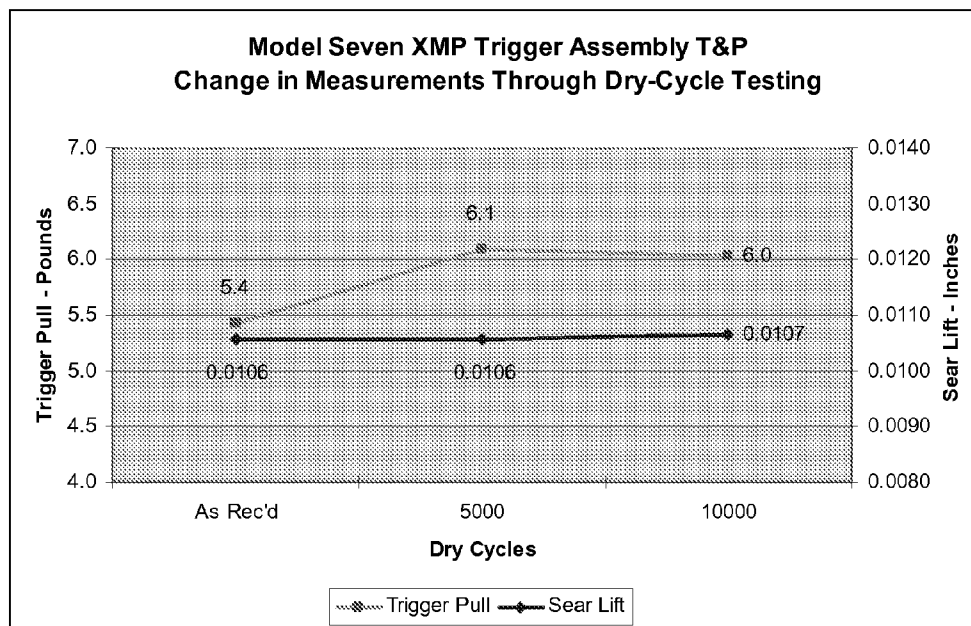
All ten trigger assemblies endured the entire 10,000 dry-cycles without damage or parts working loose. The following graph shows a ½ pound increase in trigger-pull force even though the adjustment screws held tightly. Sear-lift is shown to have held steady throughout the test at just under .011 with a specification of .008 to .018.

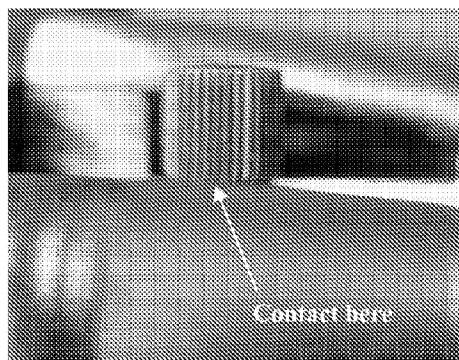
Figure 2

Another visual item noted was the tendency for the safety button to contact the right side of the bolt plug. The contact did not interfere with operation of the safety. The visual observations are summarized in the following chart and the safety button rub is depicted in the images at figures 2 and 3.

Serial #	Comments	
	Sights	Safety Arm
7815136	OK	Rubs bolt plug
7821468Z	No Sights (drilled & tapped)	Rubs bolt plug
7821557	No Sights (drilled & tapped)	Rubs bolt plug
7821852	No Sights (NOT drilled & tapped)	Rubs bolt plug
7815077	OK	OK
7820940	OK	Rubs bolt plug
7821396	OK	Rubs bolt plug
7821838	No Sights (NOT drilled & tapped)	OK
7821023	No Sights (drilled & tapped)	Rubs bolt plug

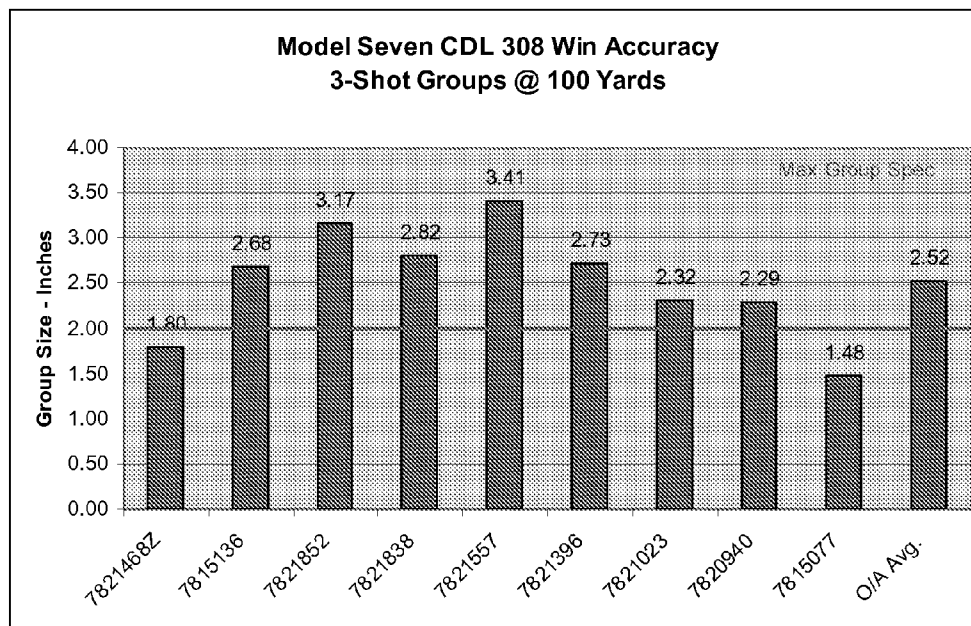
The Model Seven is normally tested for accuracy using 3-shot groups due to the small profile of the barrel and rapid heating. The 3-shot group size specification for 308 Win is 2.0 inches. The overall 9-gun average was 2.52 inches.
