**REMINGTON ARMS COMPANY INC.
ILION, NY PLANT SITE**

TEST REPORT

**M/700 LH XMP Trigger Assembly
DAT – Trial & Pilot**

Request # 20070034

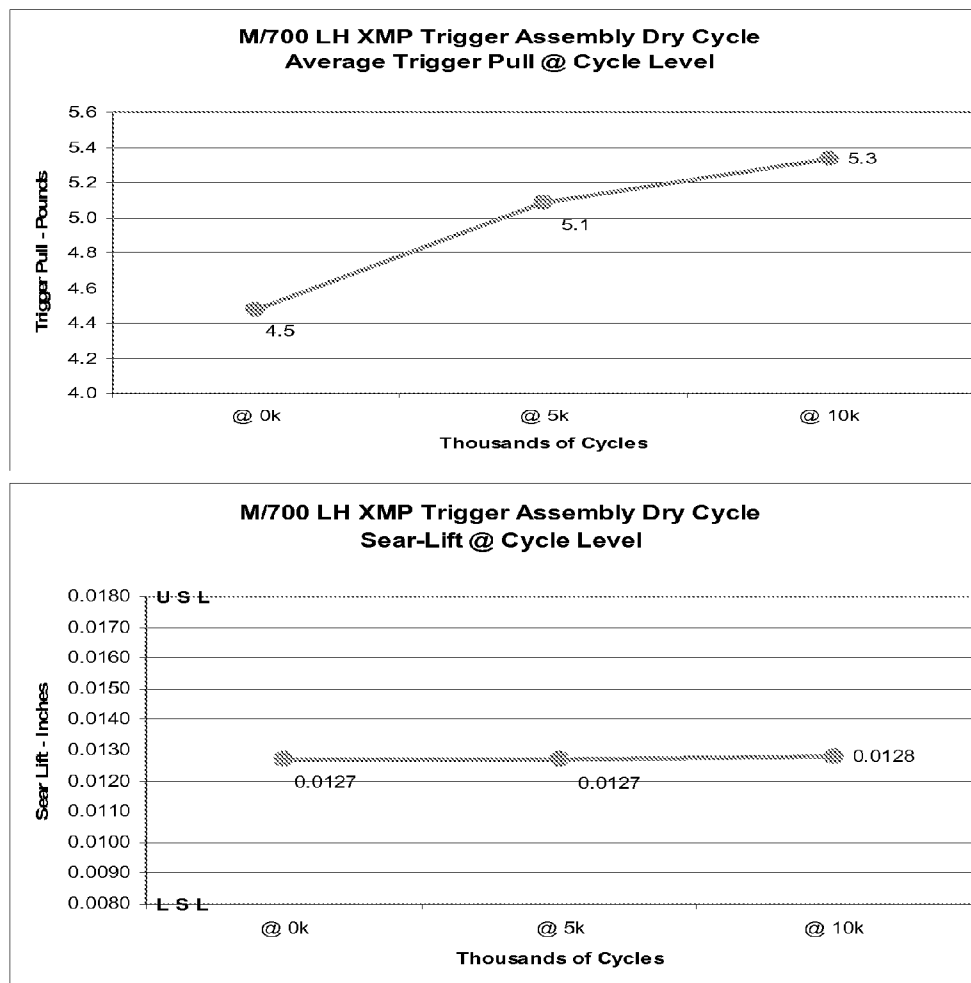
All ten trigger assemblies endured the entire 10,000 dry-cycles without damage or parts working loose. The following graph shows a .8 pound increase in trigger-pull force even though the adjustment screws held tightly. Sear-lift is shown to have held steady throughout the test at just under .013 with a specification of .008 to .018.

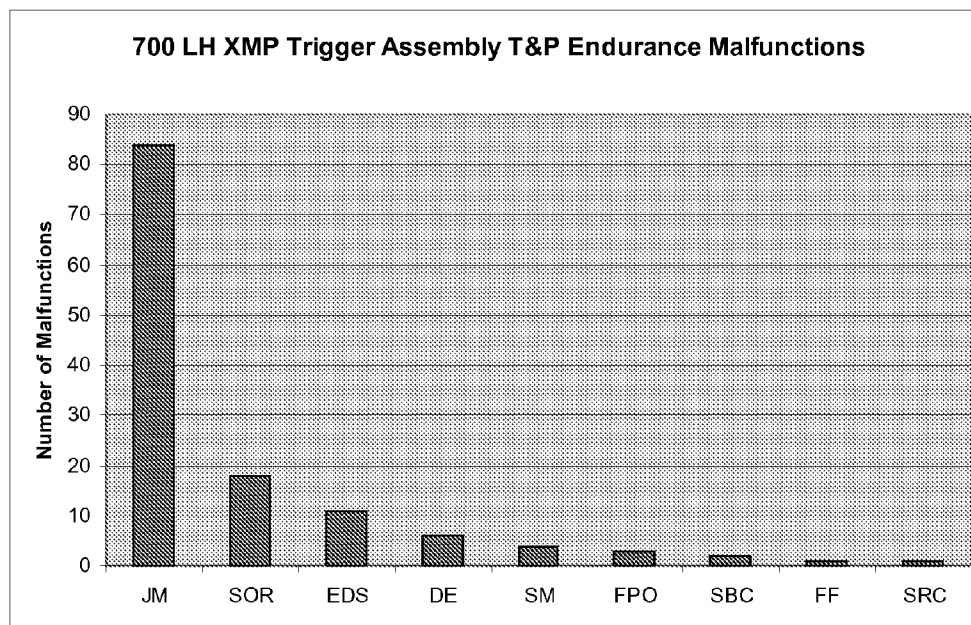
26000 rounds were fired with a total of 129 malfunctions, producing an overall malfunction rate of just 0.5%. 109 of the malfunctions were feeding related and most occurred in one rifle. The table below summarizes the malfunctions:

The single FF (Fails to Fire) malfunction on rifle A-21 was not a failure of the trigger assembly but was caused by a lack of lubrication after 360 rounds were fired. A-21 completed the remainder of the test without further incident after lubrication of the trigger assembly per instructions in the owner's manual.

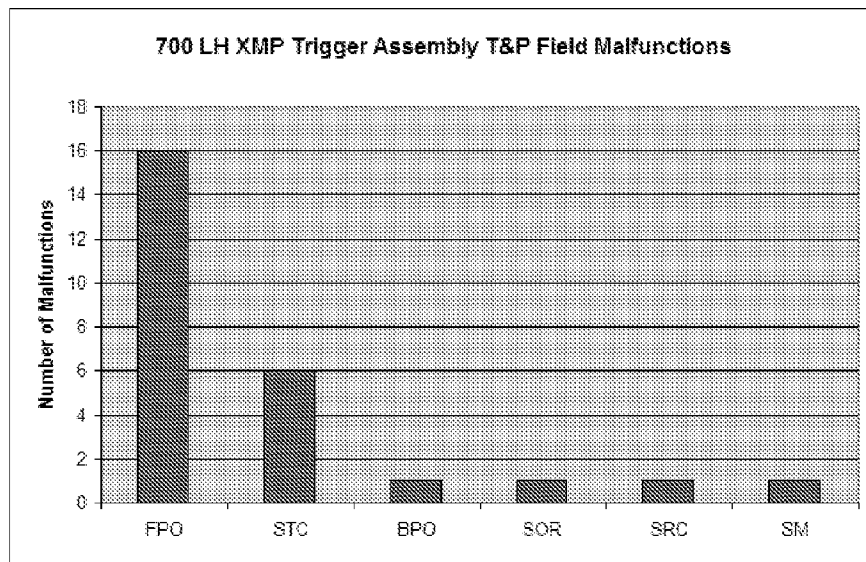
The same types of ammunition listed for the endurance test were also used to conduct the field test. 2800 total rounds of ammunition were fired through 21 rifles with an overall malfunction rate of 0.9%. 16 of the 26 malfunctions were FPO (Floor Plate Opens) occurring in the same rifle. No malfunctions were chargeable to the trigger assembly.
