Benjamin Naiman, Capt.
25 Pinsker Str.
Petah-Tiqva, Israel.

Petah-Tiqva, March 30-th, 1956.

Remington Arms Company, Inc.
Ilion, N.Y., U.S.A.

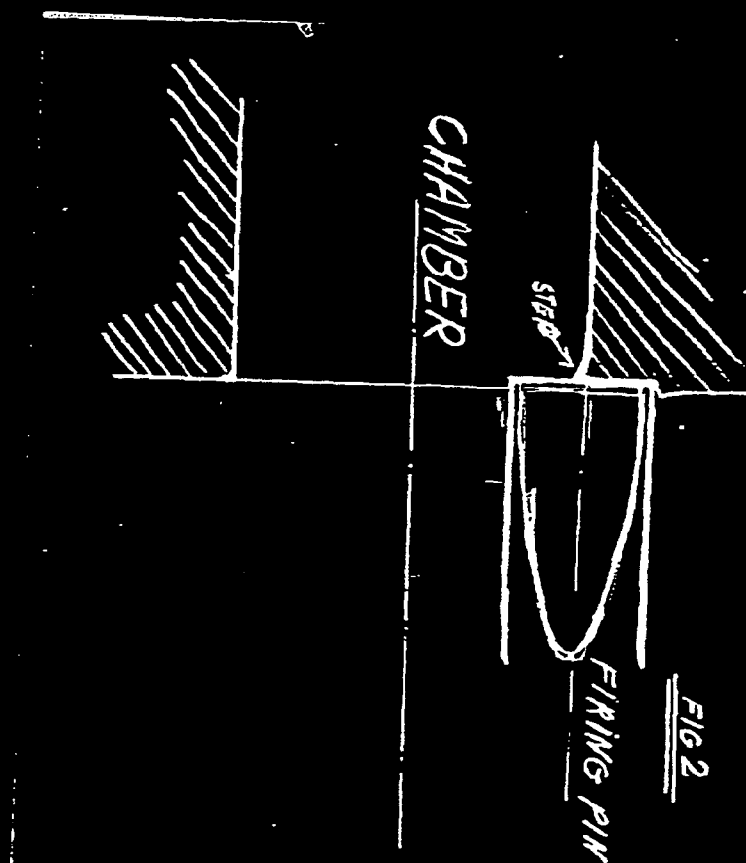
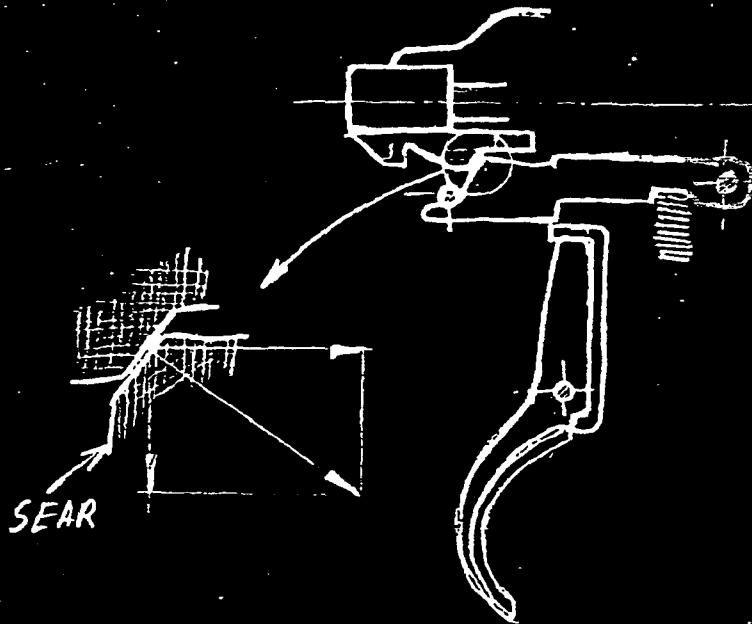
FIG 3

The disappointment came from the trigger action and here is the story: On the very day of the purchase, after several "dry shots" at home, the bolt got stuck and would not lock unless forced brutally. The safety lever would not function. The stock removed, the surface of the firing pin head was found to be riding over the sear surface. On further dismantling of the trigger mechanism, the cause was revealed: the trigger with the connector have sunk. I cannot state the cause; it was due, presumably to either the poor quality of the trigger alloy or to liberal tolerances (pins placings and such). Fig. No. 3 will illustrate the above.

PROPER POSITION

POSITION ON MY RIFLE

I had to order a new connector with a thicker head and, seeing no reason why it should not be connected to the trigger, I fixed the two bodies together by means of a 1/8" screw. The latter arrangement enabled me to replace the original heavy trigger spring by a lighter one aiming for a lighter pull. Please inform me whether you approve of the above. The click adjustment of the trigger is most convenient but unscrewing the trigger adjusting screw too much, causes the "trigger adjusting ball" to be pushed outside by the spring and removing of the stock becomes necessary. I suggest that the above be eliminated by addition of a thin pin-extension to the "trigger adjusting screw" (see fig. No.4). It proved successful on my rifle.

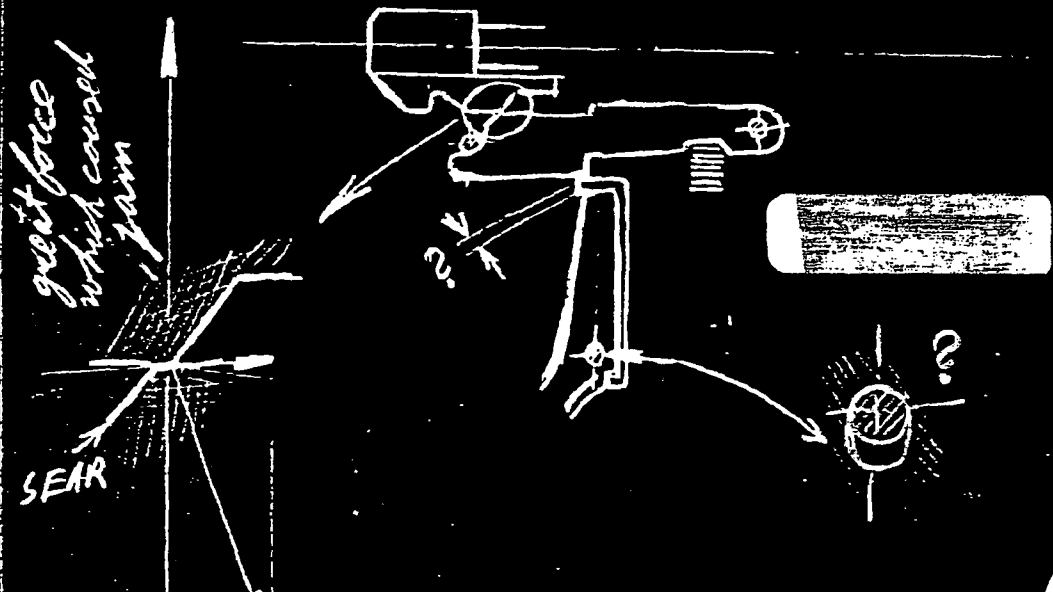
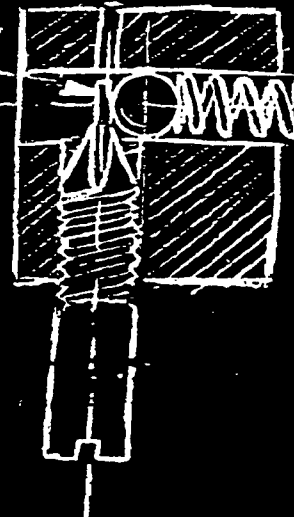
FIG 4

PIN EXTENTION
