Benjamin Naiman, Capt.
25 Pinsker Str.
Petah-Tiqva, Israel.

Petah-Tiqva, March 30-th, 1956.

Remington Arms Company, Inc.
Ilion, N.Y., U.S.A.

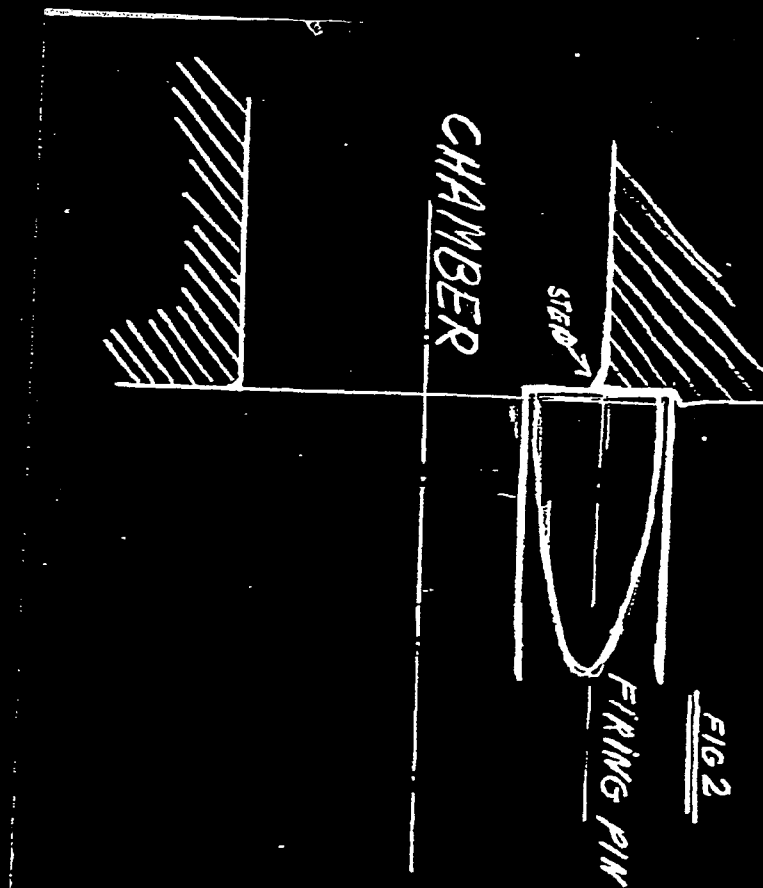
FIG 3

The disappointment came from the trigger action and here is the story: On the very day of the purchase, after several "dry shots" at home, the bolt got stuck and would not lock unless forced brutally.. The safety lever would not function. The stock removed, the surface of the firing pin head was found to be riding over the sear surface. On further dismantling of the trigger mechanism, the cause was revealed: the trigger with the connector have sunk. I cannot state the cause; it was due, presumably to either the poor quality of the trigger alloy or to liberal tolerances (pins placings and such). Fig. No. 3 will illustrate the above.

PROPER POSITION

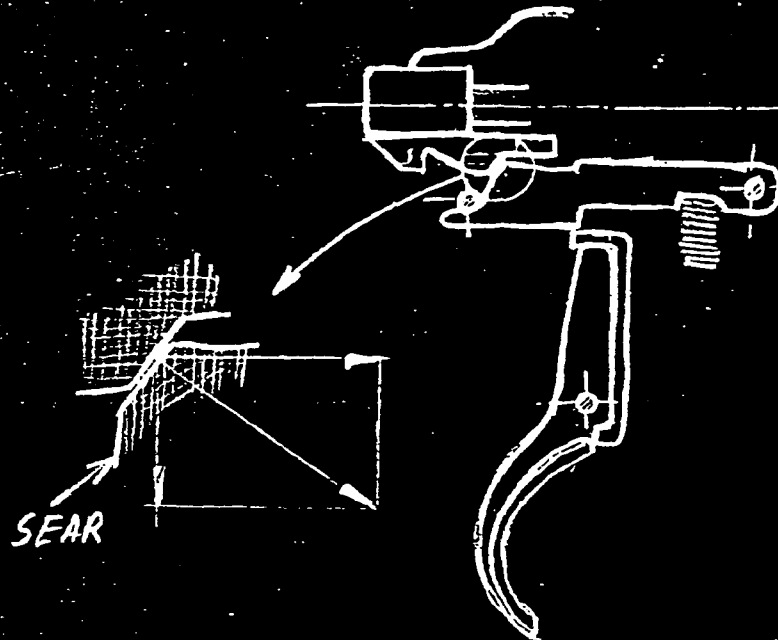
POSITION ON MY RIFLE

I had to order a new connector with a thicker head and, seeing no reason why it should not be connected to the trigger, I fixed the two bodies together by means of a 1/8" screw. The latter arrangement enabled me to replace the original heavy trigger spring by a lighter one aiming for a lighter pull. Please inform me whether you approve of the above. The click adjustment of the trigger is most convenient but unscrewing the trigger adjusting screw too much, causes the "trigger adjusting ball" to be pushed outside by the spring and removing of the stock becomes necessary. I suggest that the above be eliminated by addition of a thin pin-extension to the "trigger adjusting screw" (see fig. No.4). It proved successful on my rifle.
