## REMINGTON ARMS COMPANY, INC.

TITLE OF PROJ. 700 F/E TIPS

SUBJECT ADHESIVE STUDY -

TIPS SHOOTING OFF IN GUN

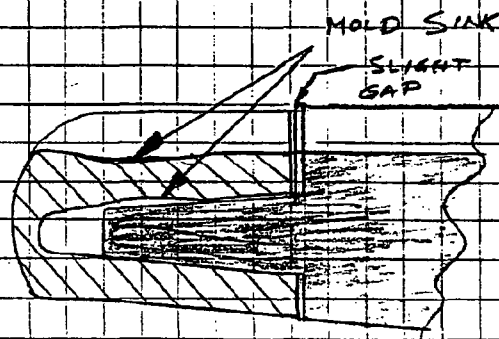
PHYSICAL MATCH OF PARTS

GAPS ARE .005" TO .010"

1. OPERATORS COMPLAIN OF SLIGHT GAP AT BOL GROOVE
2. PRESSURE POINTS SHOWN LEAVE GAP OF NO PRESSURE BUT GOOD ADHESION IS NOT NECESSARILY AT PRESSURE POINTS AS WOULD BE SUPPOSED.
3. DESIGN MIGHT BE CHANGED TO IMPROVE UNIFORMITY OF PRESSURE POINTS BUT EXTENT OF PROBLEM DOESN'T SEEM TO JUSTIFY COST.
