VISUAL INSPECTION

A-23

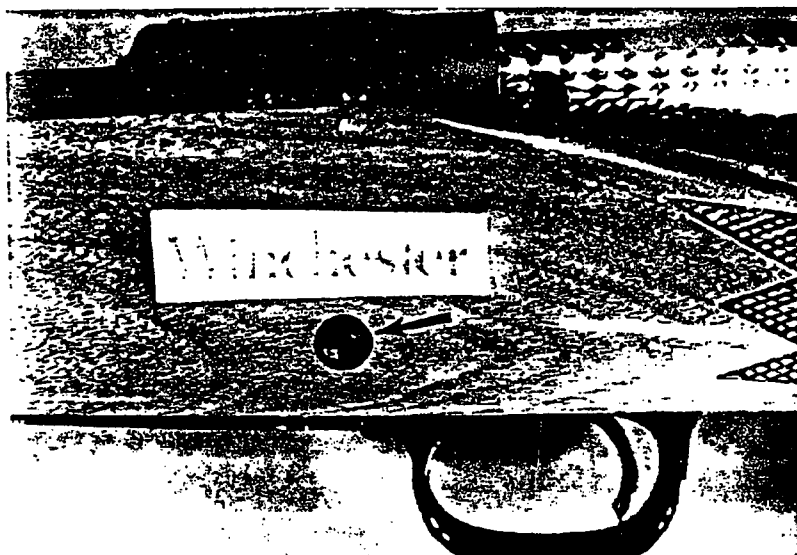
mark on  
rein-  
forcement pin.
