VIII. Browning BBR Continued

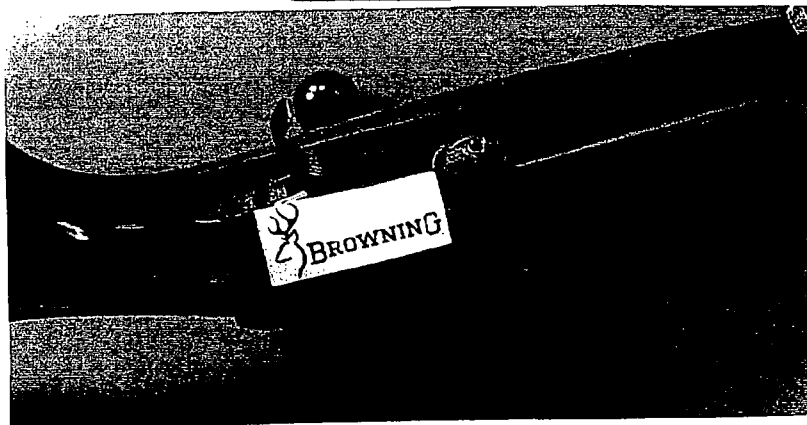
Fig. No. 4

The bolt would ride over the top of the cartridges. The rifle was taken apart and examined. An improperly factory installed spring escutcheon that the screw screwed into was the cause of the feeding problem. The spring escutcheon was halfway out of the hole and the wood around the hole was chipping away. The Model Shop tried to repair it, but they were unable to do so. (Figs. No. 4 & 5)
