VISUAL INSPECTIONS

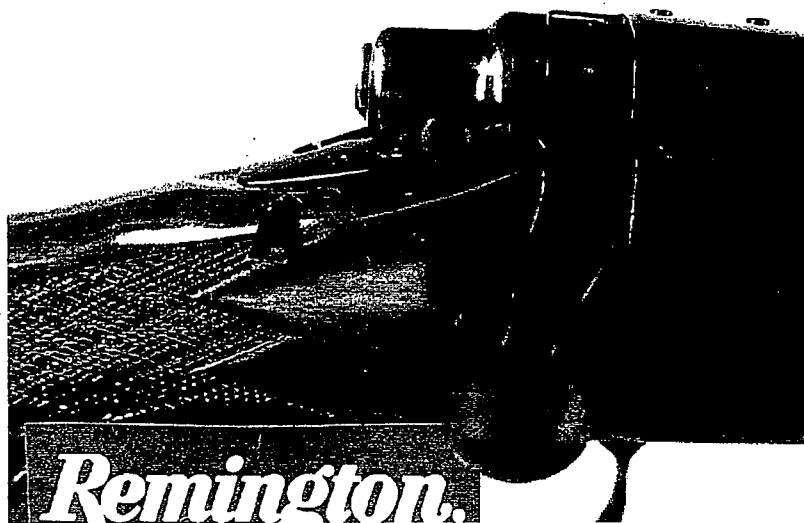
Rear Tang  
Not Flush  
with the Stock.
