Ilion, NY
January 6, 1988

Firearms Business Team
R.B. Sperling
R.K. Straitman
A.B. Dana
R.A. Blackhall
D.M. Condon

MODEL 700 TRIGGER ASSEMBLY REPLACEMENT PROGRAM

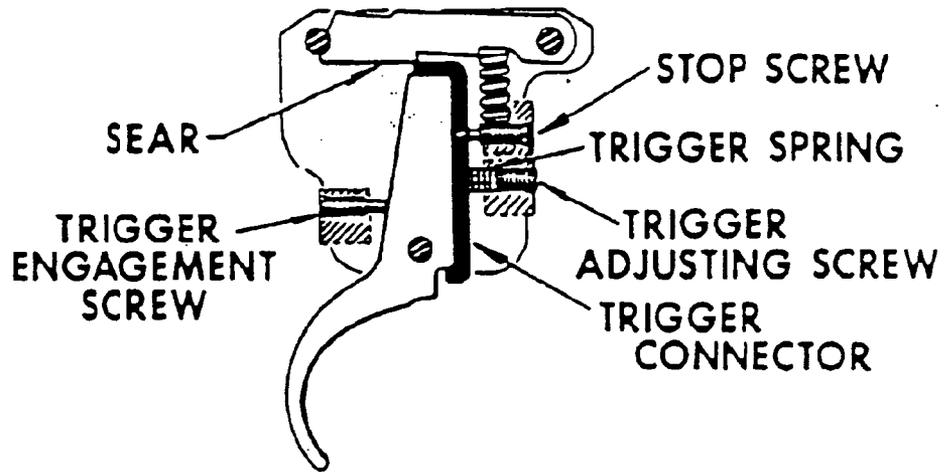
EXHIBIT A

Centerfire rifle trigger assemblies contain a part referred to as a connector that releases the sear safety cam to fire the rifle when the trigger is pulled. This part fits on the forward edge of the upper portion of the trigger assembly. (See Exhibit A)

SECTION VIEW, MODEL 700 SERIES TRIGGER ASSEMBLY
