## Section C

“The Debris Theory”

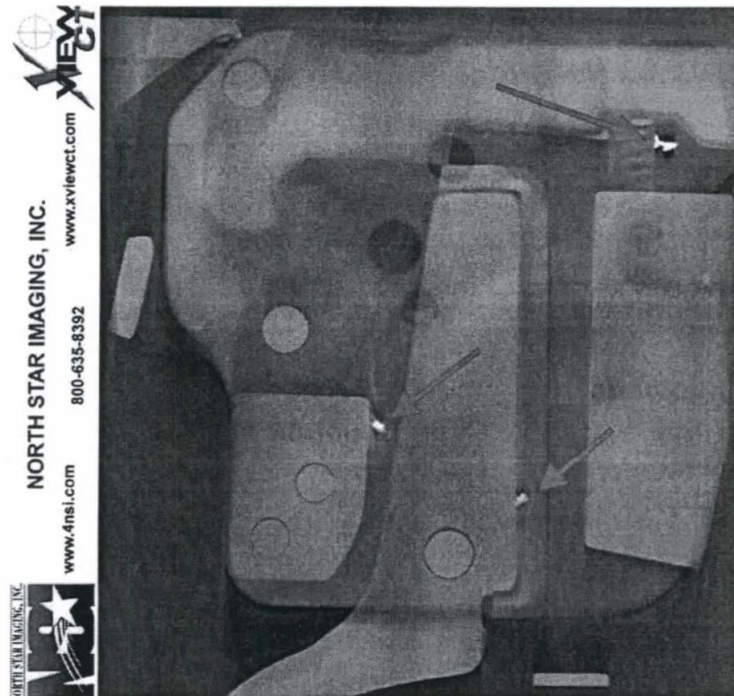
- CAT scan detected several particles of high density material that appear white on the CAT scan within the fire control assembly

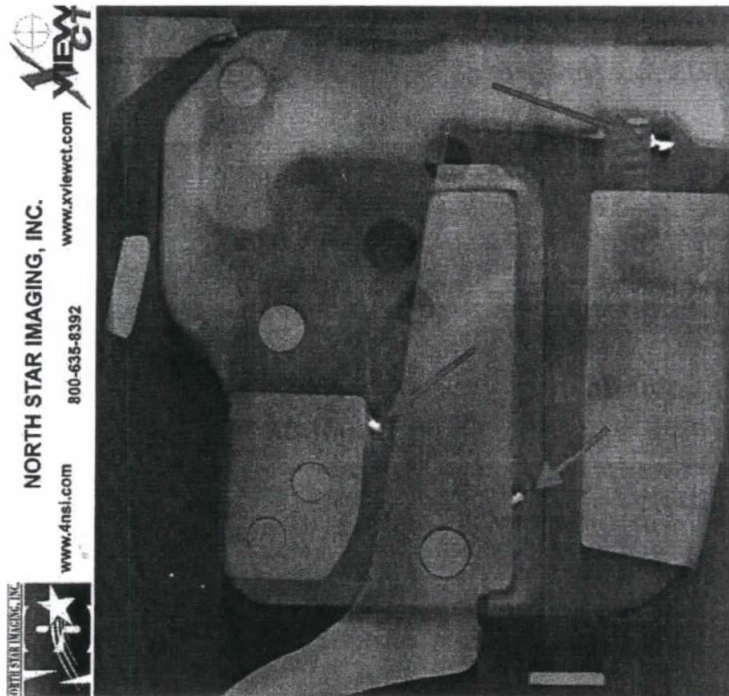
- CAT scan detected several particles of high density material that appear white on the CAT scan within the fire control assembly
