### "Screw-Driver Test"

## PROCESS RECORD CHANGE AUTHORIZATION

## M600 & M700 "SCREWDRIVER" TEST - CUSTOMER REPAIR

GUN EXAMINATION REPORT NUMBER: NO

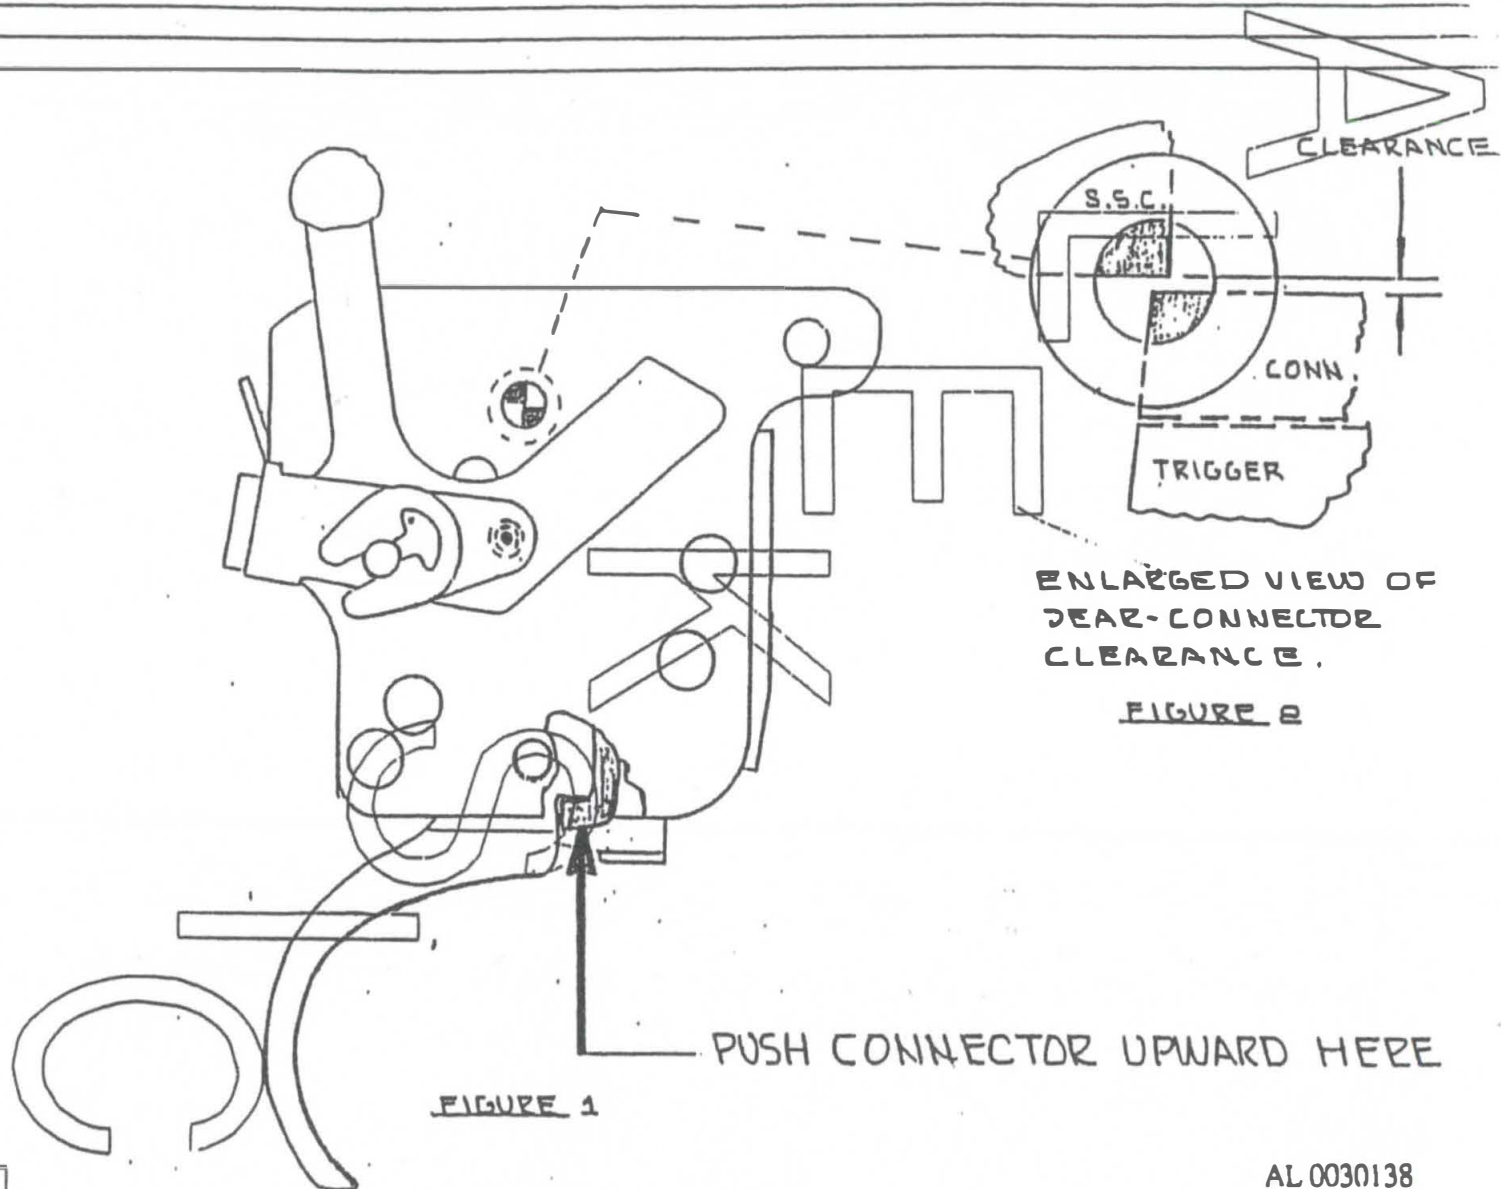
FIGURE 1

- A. With gun cocked, locate Safety lever to halfway point between "On-Safe" and "Off-Safe" location to position the safety ball detent between the indents with the Safety lever; in this unstable location insert an 1/8" wide screwdriver into the front of Trigger Housing (see Figure Pg. 6). Look through the engagement view hole to check for clearance between the Connector and Sear, while rotating Trigger back and forth. There must be clearance between the Connector and Sear, the Connector cannot catch on Sear. If clearance does not exist, install new Trigger Assembly.

ENLARGED VIEW OF  
GEAR-CONNECTOR  
CLEARANCE.
