To: Mike Keeney
From: James Urbon
Date: January 28, 2002
Re: M/710 Bolt Stops

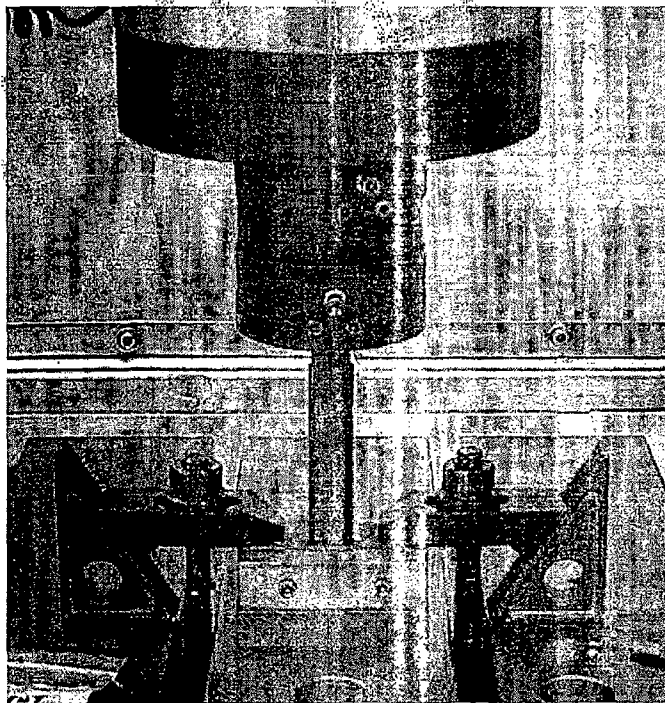
A test was designed for the Instron 8502 to overload the tip of the bolt stop where the bolt hits the bolt stop. Fixturing was made that held the bolt stop upright so that a punch could shear off the tip of the bolt stop. It was designed such that the samples could be changed without moving the fixture so that the engagement was constant sample to sample. Figures 1 and 2 show the setup on the Instron. The test was run at a rate of 0.100"/min.

Figure 1: Fixture setup on the Instron.

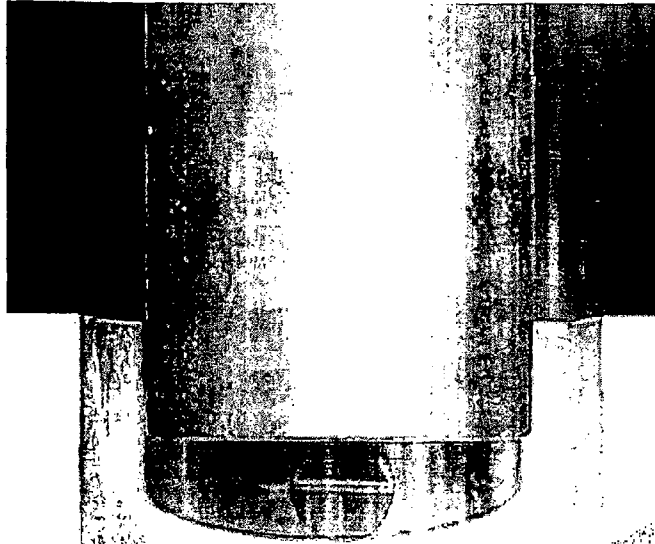
Figure 2: Close up of the punch to sample setup.

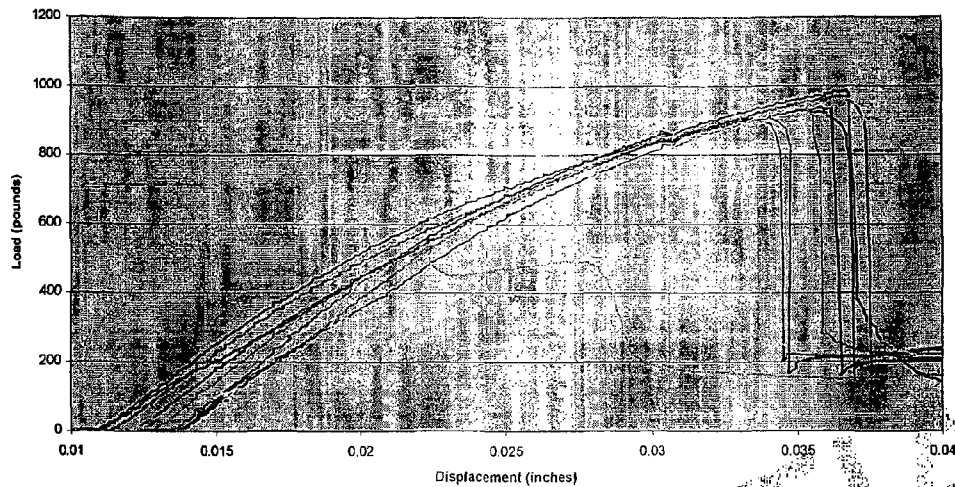
M/710 Bolt Stop - Current Production

Figure 3 is a table of the individual peak load results for the samples tested. The current production part had an average peak load of 902 lbs. and the copper infiltrated parts had an average peak load of 1150 lbs. Figures 4 and 5 show the load vs. displacement curves for the samples tested.

Figure 4: Load vs. Displacement curves for the current production samples.

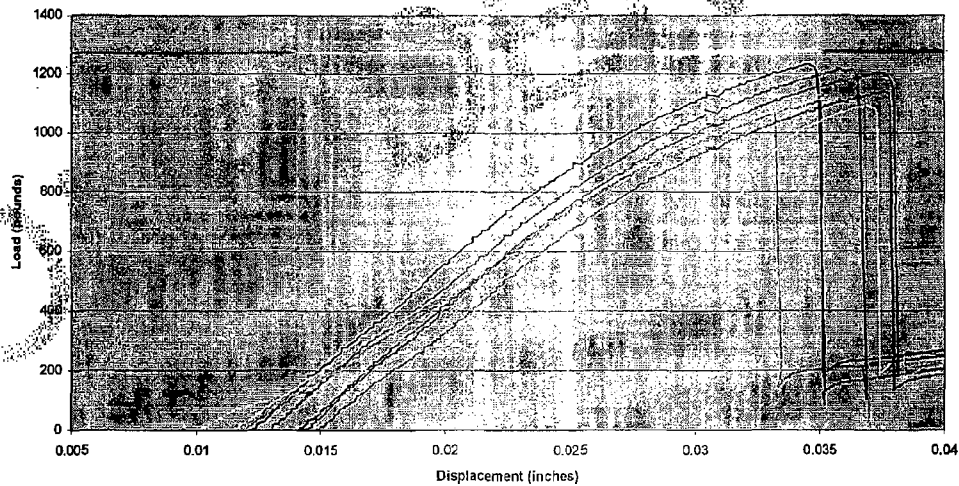
M/710 Bolt Stop - With Copper Infiltrate

Figure 5: Load vs. Displacement curves for the copper infiltrated samples.

Some issues concerning the M/710 Bolt Stop have arisen in the past few months where a few of the bolt stops have chipped in assembly each month. The problem was communicated with the vendor, Sterling Sintered, and they suggested that the part be copper infiltrated. Samples of the copper infiltrated parts were received and upon initial evaluation they seemed to help. A sample of current production parts and copper infiltrated parts were sent to the R&D Technical Center in Elizabethtown, KY for material strength evaluation.
