Ilion, NY
January 6, 1988

Firearms Business Team
R.B. Sperling
R.K. Straitman
A.B. Dana
R.A. Blackhall
D.M. Condon

MODEL 700 TRIGGER ASSEMBLY REPLACEMENT PROGRAM

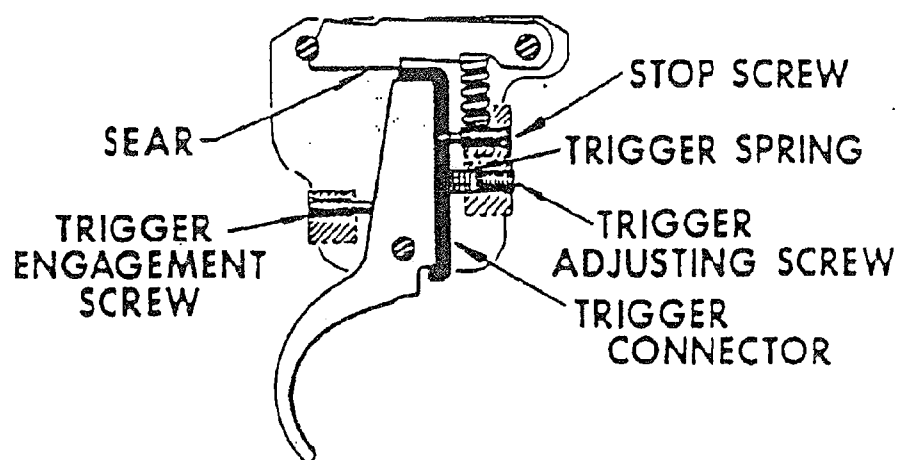
EXHIBIT A

Centerfire rifle trigger assemblies contain a part referred to as a connector that releases the sear safety cam to fire the rifle when the trigger is pulled. This part fits on the forward edge of the upper portion of the trigger assembly. (See Exhibit A)

These parts are manufactured to Remington Arms specifications by Connecticut Spring, a long-time vendor that supplies about 120 other firearms parts for Remington Firearms valued at about \$400M per year. A change was introduced to this vendor's process in April, 1987 in reaction to what was erroneously interpreted by the vendor as a heat treatment specification alteration. This change caused the flanges on either end of the parts to splay outward. These warped parts were rejected at Ilion for nonconformance to physical specifications. Connecticut Spring subsequently attempted to salvage these rejected parts by bending them back to an acceptable profile. However, because this straightening occurred after heat treatment, potential for stress cracks was introduced.

Broken connectors infrequently can get out of position and cause a malfunction by not supporting the sear safety cam. If this occurs, the firing mechanism may follow the bolt down during the loading cycle. If the safety is in the fire position this is not a dangerous situation. If the safety switch is in the safe position and the broken connector is out of correct position, the firing mechanism would be supported by the safety. Moving the safety to the fire position could then cause the rifle to fire without the trigger being pulled. If this occurred and safe gun handling practices were followed no injuries or property damage would occur.

8. About 40M extra trigger assemblies will be procured to handle the one-time effort associated with this program. Based on current estimates, it is more economical, practical, and safe to replace full assemblies rather than reconditioning assemblies. However, should a way of reconditioning be found that is more economical, practical, and safe, these parts ultimately may be used. The cost per assembly is about \$9.
