## Model 700 Trigger Assembly

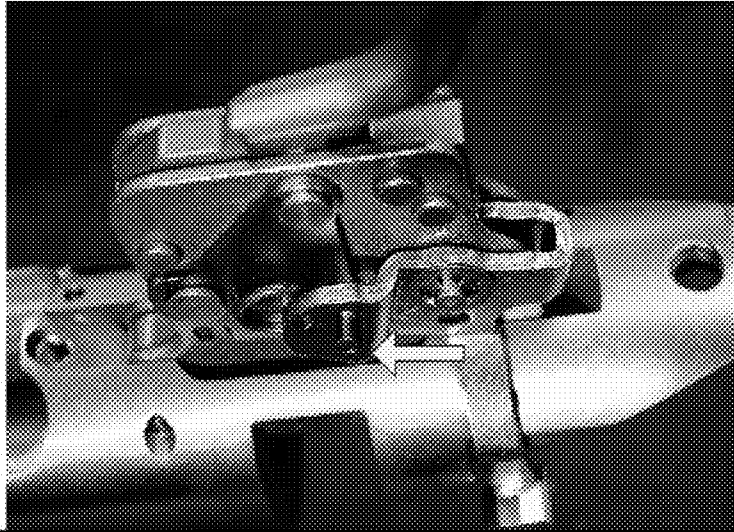
Wider- stock may need to be altered

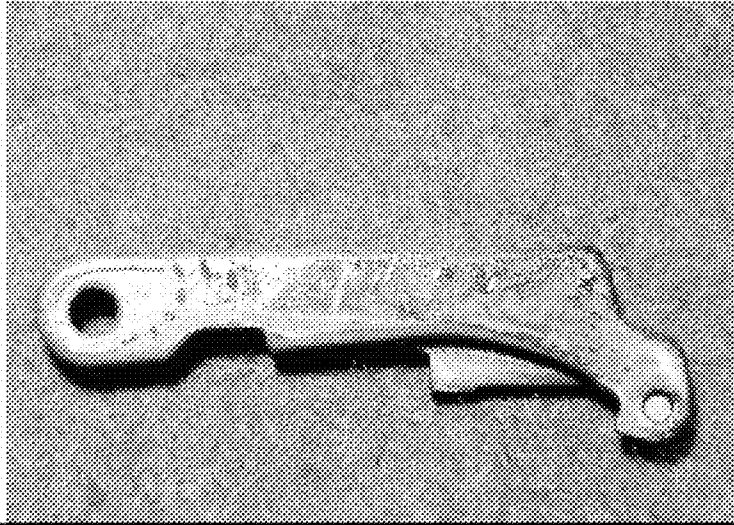
## Coagulation of oil

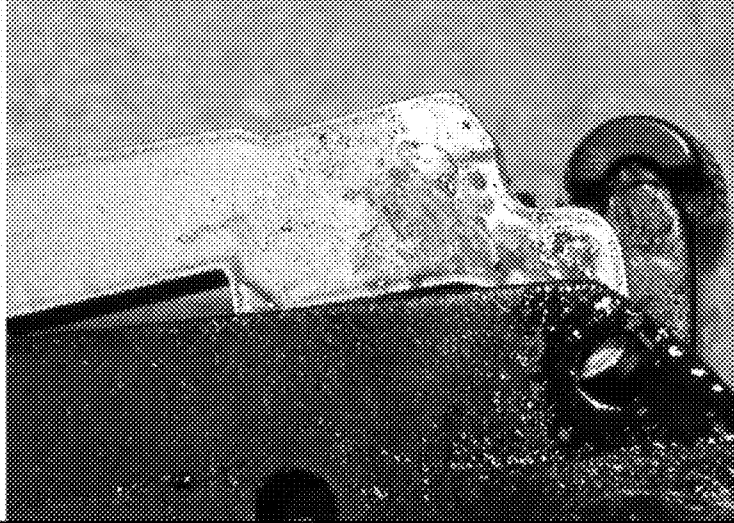
## Cleaning issue

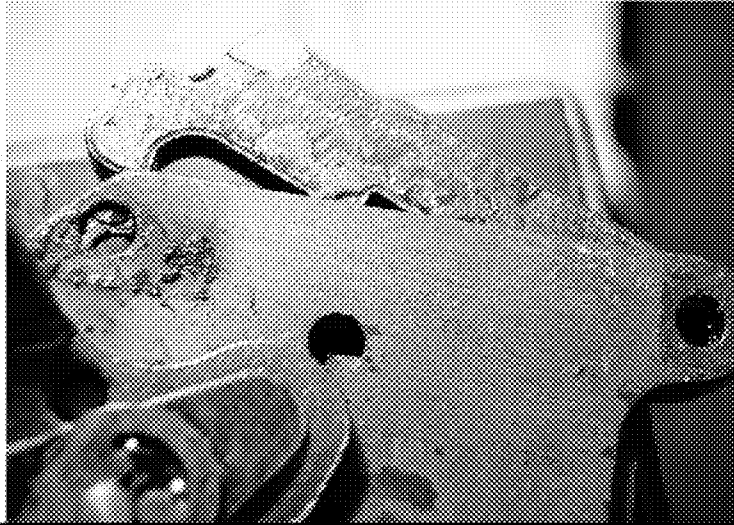
Wrong lube

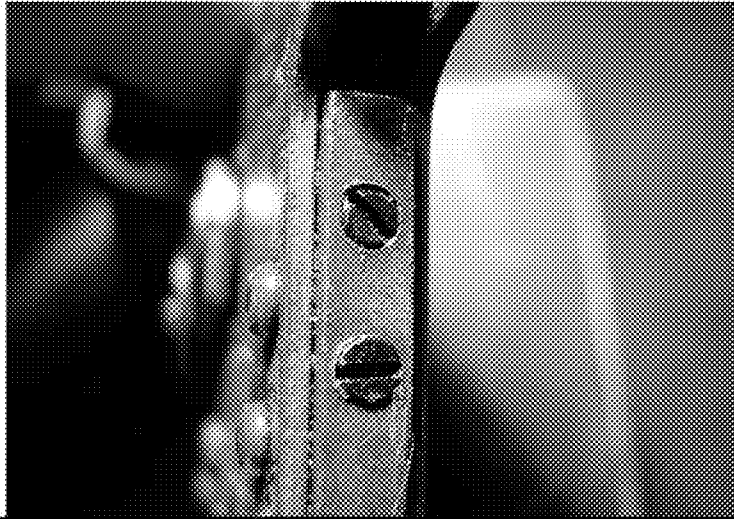
Sealant missing

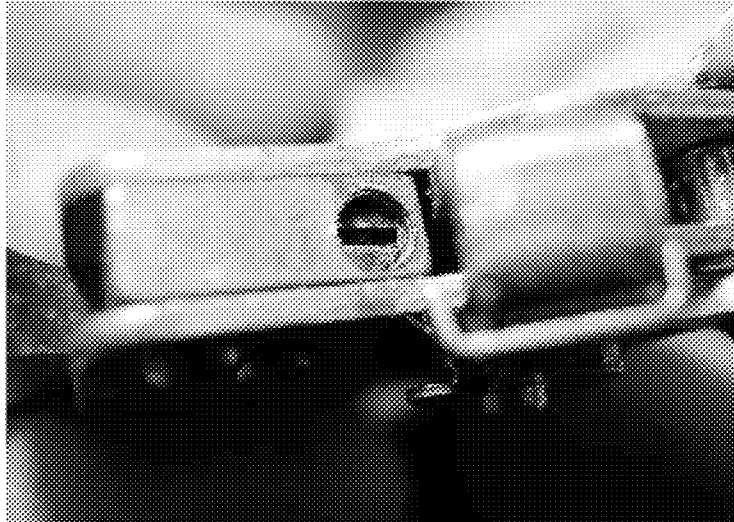
And improperly adjusted
