Case No. 4FA-89-1452 Civil  
(ABA No. 7410063)

AFFIDAVIT OF ROBERT J. BAUMAN

FAILURE MODES OF REMINGTON BOLT ACTION RIFLES

ECI FILE NO. 6477

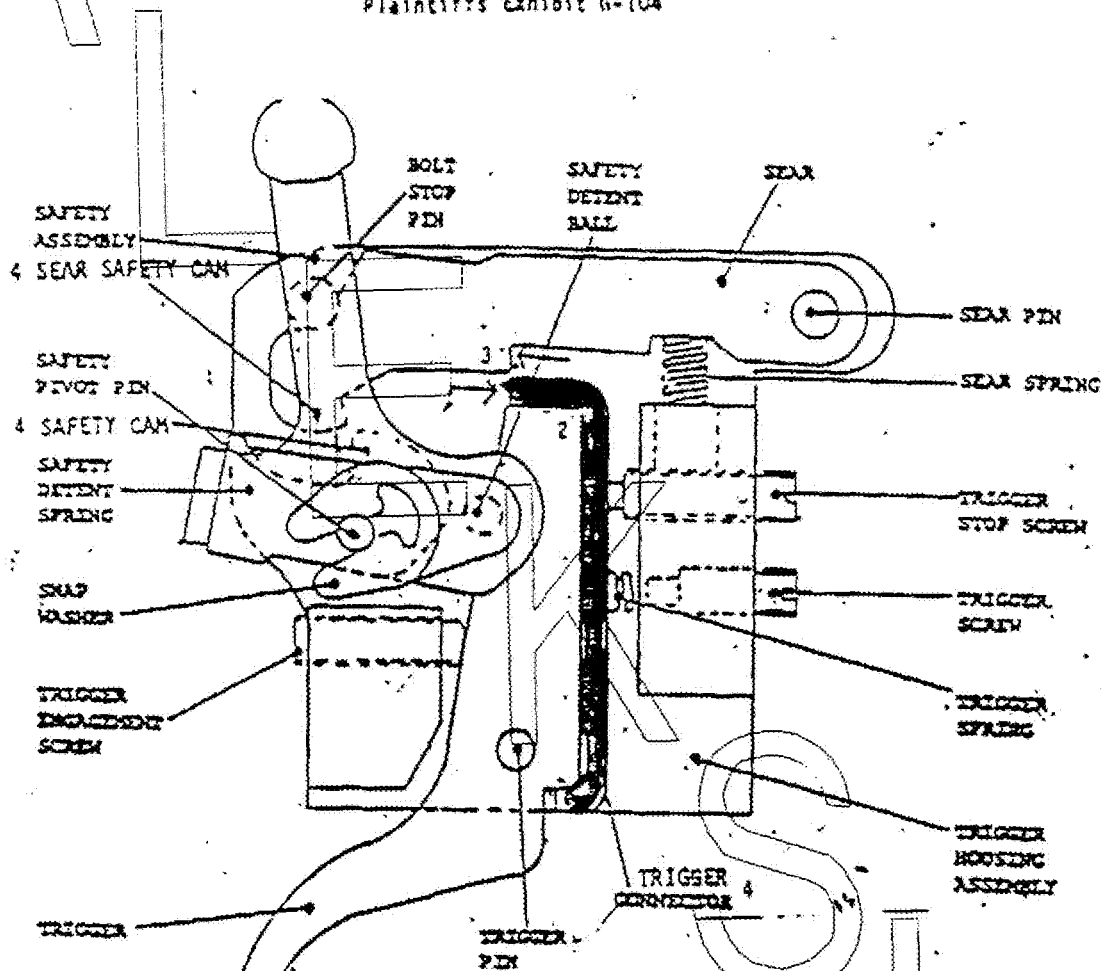
Appellees Addendum 6  
Plaintiffs' Exhibit G-104

1. The safety cam rotates counterclockwise contacting the sear safety cam and lifting the sear from the trigger connector when the safety lever is moved forward to the on safe position. The sear lift in the Levy rifle was .007 inches (T. 7/35).
2. This drawing does not show the vertical clearance between the trigger and trigger connector which was .010 inches in the Levy rifle (T. 7/38).
3. The horizontal interference between the trigger connector and sear which was up to .003 (.010 -.007) inches in the Levy rifle prevents the trigger connector from returning under the sear to provide support when the safety is moved to the off position (T. 8/52).
4. Appellees have added labels to G-104 in order to pictorially explain the function of the Walker fire control system and FSRs to the Court.
