TRIAL AND PILOT TEST REPORT

**Model 770 Stainless Steel
Bolt Action Rifle**

**TLW 2305
300 Win Mag
30-06 Sprg
243 Win Youth**

**TLW 2359
7mm Rem Mag
270 Win**

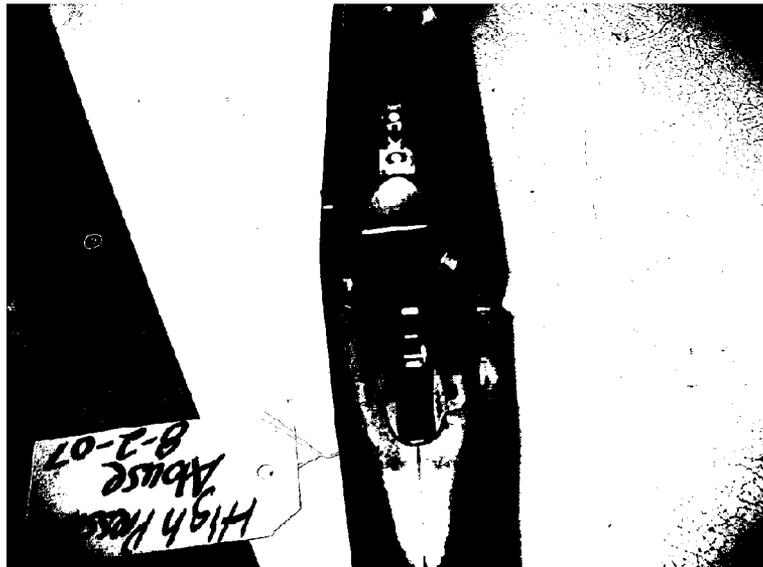
High pressure abusive testing was performed on one rifle, A9, using SAAMI and Remington test procedures. The rifle selected for this test, A9, was chambered for the 300 Win Mag cartridge, representing the most sever scenario. The rifle had a strain gage place over the chamber portion of the barrel in the hoop direction. Three SAAMI reference rounds were fired through the rifle followed by three SAAMI Proof rounds. The rifle was then subjected to a 120,000 psi abuse round. The load for the abuse round was 71.5 grains of IMR 3031 Lot # E97AU19L1500. The result of this test were consistent with previously tested carbon steel product. The rifle remained intact; however, the strain data captured, seen in figure 11, shows that the barrel did take a permanent deformation set of approximately 300 $\mu\epsilon$ / ". The bolt required the use of a hammer to be opened. Figures 12 – 14 documents the condition of the rifle post test.

Figure 12: Gun A9 post abusive testing.
